Access Compliance Report

Public Rights-of-Way

(Curb Ramps)

Intersection ID: 44213	Main Street: GOLDEN_APPLE_CT	Cross Street: MOCKERNUT_DR	Location:	W
ADA ID: DCF7EC728B3B	Ramp Type: Perp	Initial Pass/Fail: Fail	Overall Compliance: No	Severity Score: 8.75
Codes/Mitigation Info/Possible Solution		Field Measurements/Component Compliance

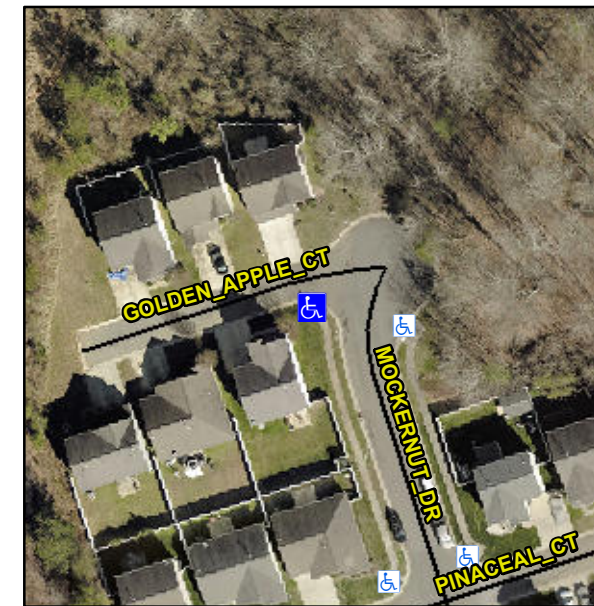
Not Found, R304.5.1

Compliance	Description	Data	Compliance	Description	Data
N/A	Ramp Length (in)	49.5	Yes	Ramp Slope (%)	8.0
No	Ramp Width (in)	47.5	Yes	Ramp XSlope (%)	1.3
N/A	Flare Type LT	N/A	N/A	Flare Type RT	N/A
N/A	Flare Slope LT (%)	N/A	N/A	Flare Slope RT (%)	N/A
N/A	Flare Traversable LT?	N/A	N/A	Flare Traversable RT?	N/A
N/A	Landing Length (in)	N/A	N/A	DWS Provided?	N/A
N/A	Landing Width (in)	N/A	N/A	DWS Contrast?	N/A
N/A	Landing Slope (%)	N/A	N/A	DWS Length (in)	N/A
N/A	Landing X Slope (%)	N/A	N/A	DWS Full Width?	N/A
N/A	Landing Curb? (Y/N)	N/A	N/A	DWS Offset (in)	N/A
N/A	Shared Landing?	N/A			
N/A	Gutter Ponding?	N/A	N/A	Gutter Slope (%)	N/A
N/A	Gutter Lip Ht (in)	N/A	N/A	Gutter X Slope (%)	N/A
N/A	Painted X Walk1?	No	N/A	Painted X Walk2?	N/A
	X Walk 1 Direction	To SE		X Walk 2 Direction	N/A
N/A	X Walk 1 Width (in)	N/A	N/A	X Walk 2 Width (in)	N/A
	X Walk 1 Slope (%)	3.6		X Walk 2 Slope (%)	N/A
	X Walk 1 X Slope (%)	1.4		X Walk 2 X Slope (%)	N/A

N/A	Ramp inside XWalk1?	N/A	N/A	Ramp inside XWalk2?	N/A
	Road Slope (%)	N/A	N/A	Clear Space?	N/A
	Road X Slope (%)	N/A	N/A	Clear Space to XWalk (in)	N/A
N/A	Any Obstructions?	N/A	N/A	Storm Grate/Utility Hazard?	N/A
	Obstruction Type			Storm Grate/Utility Type	
		N/A			N/A
			Yes	Surface Condition? (G/P)	Good

Remove & Replace Entire Ramp.
