Access Compliance Report

Public Rights-of-Way

(Curb Ramps)

Intersection ID: 10040974	Main Street: WALSH_BV	Cross Street: N/A	Location: S
ADA ID: DD00558C2556	Ramp Type: PerpDiag	Initial Pass/Fail: Fail	Overall Compliance: No
Severity Score: 58.75			
Codes/Mitigation Info/Possible Solution		Field Measurements/Component Compliance

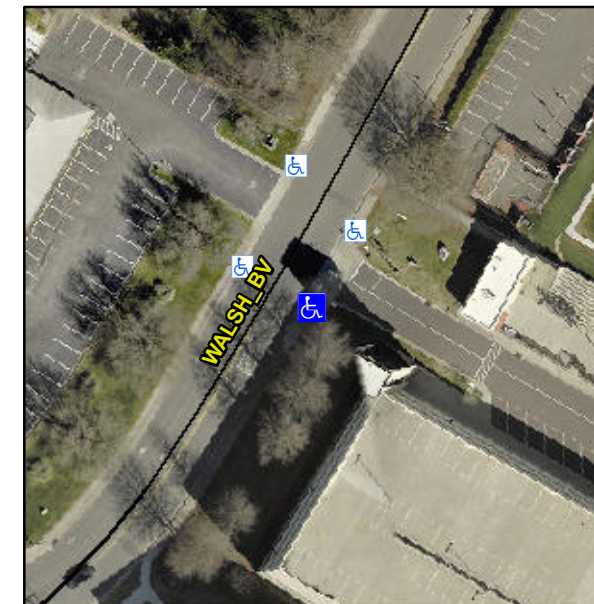
Not Found, R304.5.1, R304.2.2, R304.5.3

Compliance	Description	Data	Compliance	Description	Data
N/A	Ramp Length (in)	61.0	No	Ramp Slope (%)	13.7
No	Ramp Width (in)	41.0	No	Ramp XSlope (%)	7.5
N/A	Flare Type LT	N/A	N/A	Flare Type RT	N/A
N/A	Flare Slope LT (%)	N/A	N/A	Flare Slope RT (%)	N/A
N/A	Flare Traversable LT?	N/A	N/A	Flare Traversable RT?	N/A
N/A	Landing Length (in)	N/A	N/A	DWS Provided?	N/A
N/A	Landing Width (in)	N/A	N/A	DWS Contrast?	N/A
N/A	Landing Slope (%)	N/A	N/A	DWS Length (in)	N/A
N/A	Landing X Slope (%)	N/A	N/A	DWS Full Width?	N/A
N/A	Landing Curb? (Y/N)	N/A	N/A	DWS Offset (in)	N/A
N/A	Shared Landing?	N/A			
N/A	Gutter Ponding?	N/A	N/A	Gutter Slope (%)	N/A
N/A	Gutter Lip Ht (in)	N/A	N/A	Gutter X Slope (%)	N/A
N/A	Painted X Walk1?	No	N/A	Painted X Walk2?	No
	X Walk 1 Direction	To NE		X Walk 2 Direction	To NW
N/A	X Walk 1 Width (in)	N/A	N/A	X Walk 2 Width (in)	N/A
	X Walk 1 Slope (%)	0.2		X Walk 2 Slope (%)	4.6
	X Walk 1 X Slope (%)	8.9		X Walk 2 X Slope (%)	0.5

N/A	Ramp inside XWalk1?	N/A	N/A	Ramp inside XWalk2?	N/A
	Road Slope (%)	4.3	N/A	Clear Space?	N/A
	Road X Slope (%)	3.2	N/A	Clear Space to XWalk (in)	N/A
N/A	Any Obstructions?	N/A	N/A	Storm Grate/Utility Hazard?	N/A
	Obstruction Type			Storm Grate/Utility Type	
		N/A			N/A
			Yes	Surface Condition? (G/P)	Good

Remove & Replace Curb Ramp With Two New Directional Ramps or Equivalent.
