Access Compliance Report

Public Rights-of-Way

(Curb Ramps)

Intersection ID: 10180	Main Street: FERN_AV	Cross Street: TUCKASEEGEE_RD	Location: NE
ADA ID: DD04FFDEB72D	Ramp Type: Perp	Initial Pass/Fail: Fail	Overall Compliance: No
		Severity Score: 12.5

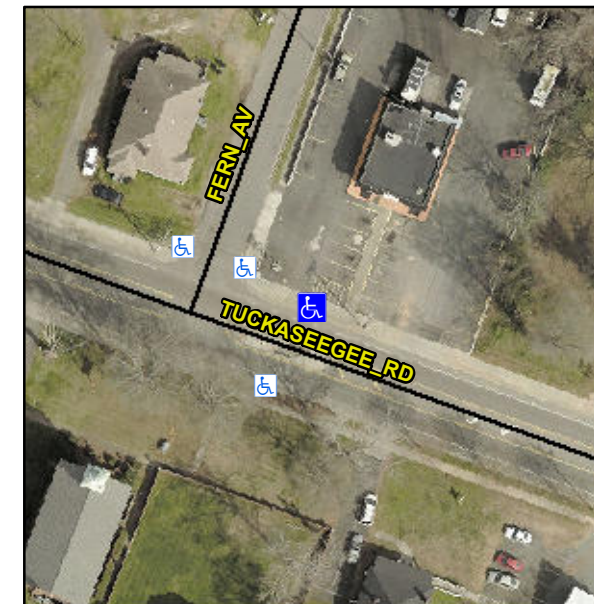
Not Found, R304.2.2

Compliance	Description	Data	Compliance	Description	Data
N/A	Ramp Length (in)	82.5	No	Ramp Slope (%)	8.4
Yes	Ramp Width (in)	48.0	Yes	Ramp XSlope (%)	0.9
N/A	Flare Type LT	N/A	N/A	Flare Type RT	N/A
N/A	Flare Slope LT (%)	N/A	N/A	Flare Slope RT (%)	N/A
N/A	Flare Traversable LT?	N/A	N/A	Flare Traversable RT?	N/A
N/A	Landing Length (in)	N/A	N/A	DWS Provided?	N/A
N/A	Landing Width (in)	N/A	N/A	DWS Contrast?	N/A
N/A	Landing Slope (%)	N/A	N/A	DWS Length (in)	N/A
N/A	Landing X Slope (%)	N/A	N/A	DWS Full Width?	N/A
N/A	Landing Curb? (Y/N)	N/A	N/A	DWS Offset (in)	N/A
N/A	Shared Landing?	N/A			
N/A	Gutter Ponding?	N/A	N/A	Gutter Slope (%)	N/A
N/A	Gutter Lip Ht (in)	N/A	N/A	Gutter X Slope (%)	N/A
N/A	Painted X Walk1?	No	N/A	Painted X Walk2?	N/A
	X Walk 1 Direction	To S		X Walk 2 Direction	N/A
N/A	X Walk 1 Width (in)	N/A	N/A	X Walk 2 Width (in)	N/A
	X Walk 1 Slope (%)	4.4		X Walk 2 Slope (%)	N/A
	X Walk 1 X Slope (%)	0.5		X Walk 2 X Slope (%)	N/A

N/A	Ramp inside XWalk1?	N/A	N/A	Ramp inside XWalk2?	N/A
	Road Slope (%)	N/A	N/A	Clear Space?	N/A
	Road X Slope (%)	N/A	N/A	Clear Space to XWalk (in)	N/A
N/A	Any Obstructions?	N/A	N/A	Storm Grate/Utility Hazard?	N/A
	Obstruction Type			Storm Grate/Utility Type	
		N/A			N/A
			Yes	Surface Condition? (G/P)	Good

Remove & Replace Entire Ramp.
