## **Access Compliance Report Public Rights-of-Way** (Curb Ramps)

Intersection ID: 10037292 Main Street: SARDIS RD **Cross Street: N/A** Location: ADA ID: DD0770984F6A Ramp Type: PerpDiag Initial Pass/Fail: Fail **Overall Compliance: No** Severity Score: 21.25

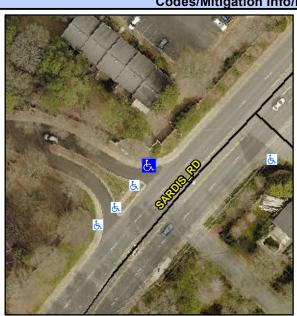
| Compl | Compliance Description | | Compl | iance Description | Data |
|---|---|---|---|---|---|
| N/A | Ramp Length (in) | 60.0 | No | Ramp Slope (%) | 9.1 |
| No | Ramp Width (in) | 43.0 | Yes | Ramp XSlope (%) | 1.8 |

Street 1 Name Stop Condition-Street 2 Street 2 Name Stop Condition-Street 1 Remove & Replace Curb Ramp With **Two New Directional Ramps or** Equivalent.

R304.5.1, R304.2.2

> Total Cost: 3200.00
