## **Access Compliance Report Public Rights-of-Way** (Curb Ramps)

Intersection ID: 1002972 Main Street: ALOYSIA\_LN Cross Street: N/A Location: SE **Overall Compliance: No** ADA ID: DD163790D273 Ramp Type: Perp Initial Pass/Fail: Fail **Severity Score:** 12.5

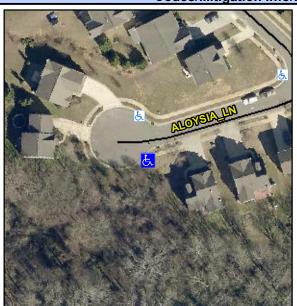
Field Measurements/Component Compliance							
Compli	ance Description	Data	Compli	ance	Description	Data	
N/A	Ramp Length (in)	47.5	No	Ramp	Slope (%)	8.6	
Yes	Ramp Width (in)	50.5	Yes	Ramp	XSlope (%)	1.3	
N/A	Flare Type LT	N/A	N/A	Flare	Type RT	N/A	
N/A	Flare Slope LT (%)	N/A	N/A	N/A Flare Slope RT (%)		N/A	
N/A	Flare Traversable LT?	N/A	N/A	Flare	Traversable RT?	N/A	
N/A	Landing Length (in)	N/A	N/A	DWS	Provided?	N/A	
N/A	Landing Width (in)	N/A	N/A	DWS	Contrast?	N/A	
N/A	Landing Slope (%)	N/A	N/A	DWS	Length (in)	N/A	
N/A	Landing X Slope (%)	N/A	N/A	DWS	Full Width?	N/A	
N/A	Landing Curb? (Y/N)	N/A	N/A	DWS	Offset (in)	N/A	
N/A	Shared Landing?	N/A					
N/A	Gutter Ponding?	N/A	N/A	Gutte	r Slope (%)	N/A	
N/A	Gutter Lip Ht (in)	N/A	N/A	Gutte	r X Slope (%)	N/A	
N/A	Painted X Walk1?	No	N/A	Painte	ed X Walk2?	N/A	
	X Walk 1 Direction	To NW		X Wa	lk 2 Direction	N/A	
N/A	X Walk 1 Width (in)	N/A	N/A	X Wa	lk 2 Width (in)	N/A

X Walk 1 Slope (%)	3.3		X Wa	lk 2 Slope (%)	N/A	
	X Walk 1 X Slope (%)	3.5		X Wa	lk 2 X Slope (%)	N/A	
N/A	Ramp inside XWalk1?	N/A	N/A	Ramp	inside XWalk2?	N/A	
	Road Slope (%)	N/A	N/A	Clear	Space?	N/A	
	Road X Slope (%)	N/A	N/A	Clear	Space to XWalk (in)	N/A	
N/A	Any Obstructions?	N/A	N/A	Storm	Grate/Utility Hazard?	N/A	
	Obstruction Type			Storm	Grate/Utility Type		
		N/A				N/A	
			Yes	Surfa	ce Condition? (G/P)	Good

Possible Solution
Possible Solutions:
Remove & Replace Entire Ramp.
Surveyor Notes:
N/A
PROW/ADA:
Not Found, R304.2.2
