## Access Compliance Report Public Rights-of-Way (Curb Ramps)

Intersection ID: 17409 Main Street: HILLSIDE\_AV Cross Street: PARK\_RD Location: NE

ADA ID: DD1B5FEDED7B Ramp Type: BlendTrans2 Initial Pass/Fail: Fail Overall Compliance: No Severity Score: 35

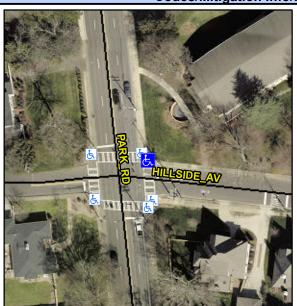
Not Found, R304.5.1

Yes BlendTrans Slope (%) N/A Ramp Length (in) 67.0 0.9 Yes No Ramp Width (in) 26.0 BlendTrans XSlope (%) 2.0 N/A N/A Flare Type LT N/A Flare Type RT N/A N/A Flare Slope LT (%) N/A N/A Flare Slope RT (%) N/A N/A Flare Traversable LT? N/A N/A Flare Traversable RT? N/A N/A Landing Length (in) N/A N/A DWS Provided? N/A N/A Landing Width (in) N/A N/A **DWS Contrast?** N/A N/A N/A N/A Landing Slope (%) DWS Length (in) N/A N/A Landing X Slope (%) N/A N/A DWS Full Width? N/A N/A Landing Curb? (Y/N) N/A N/A DWS Offset (in) N/A N/A N/A Shared Landing? N/A **Gutter Ponding?** N/A N/A Gutter Slope (%) N/A N/A Gutter Lip Ht (in) N/A N/A Gutter X Slope (%) N/A N/A Painted X Walk1? Yes N/A Painted X Walk2? N/A X Walk 1 Direction To S X Walk 2 Direction N/A 110.0 X Walk 1 Width (in) X Walk 2 Width (in) N/A X Walk 1 Slope (%) 2.2 X Walk 2 Slope (%) N/A X Walk 1 X Slope (%) 3.5 X Walk 2 X Slope (%) N/A N/A Ramp inside XWalk2? N/A Ramp inside XWalk1? Yes N/A Road Slope (%) 3.5 Clear Space? N/A Road X Slope (%) 2.2 N/A Clear Space to XWalk (in) N/A N/A N/A N/A Any Obstructions? Storm Grate/Utility Hazard? N/A **Obstruction Type** Storm Grate/Utility Type N/A N/A Yes Surface Condition? (G/P) Good No Curb Slope (%) 10.5

Possible Solutions:

Remove & Replace Curb Ramp With Two New Directional Ramps or Equivalent.
