# Access Compliance Report

## Public Rights-of-Way

### (Curb Ramps)

| Intersection ID: 23815 | Main Street: CARMEL_RD | Cross Street: MONTIBELLO_DR | Location: SW |

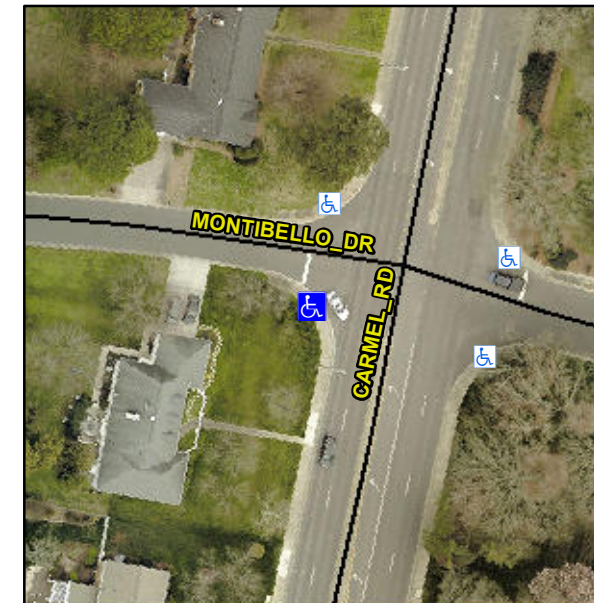
| ADA ID: DD1CE5593DAE | Ramp Type: PerpDiag | Initial Pass/Fail: Fail | Overall Compliance: No |
| | | | Severity Score: 21.25 |

**Not Found, R304.5.1, R304.2.2**

| Compliance | Description | Data | Compliance | Description | Data |
|---|---|---|---|---|---|
| N/A | Ramp Length (in) | 60.0 | No | Ramp Slope (%) | 8.9 |
| No | Ramp Width (in) | 39.0 | Yes | Ramp XSlope (%) | 0.9 |

**Remove & Replace Curb Ramp With Two New Directional Ramps or Equivalent.**

Total Cost: \$ 3200.00
