Access Compliance Report

Public Rights-of-Way

(Curb Ramps)

Intersection ID: 10270	Main Street: FONTANA_AV	Cross Street: SPRING_ST	Location: SW
ADA ID: DD2572836181	Ramp Type: Perp	Initial Pass/Fail: Fail	Overall Compliance: No
Codes/Mitigation Info/Possible Solution		Field Measurements/Component Compliance	
Severity Score: 13.75

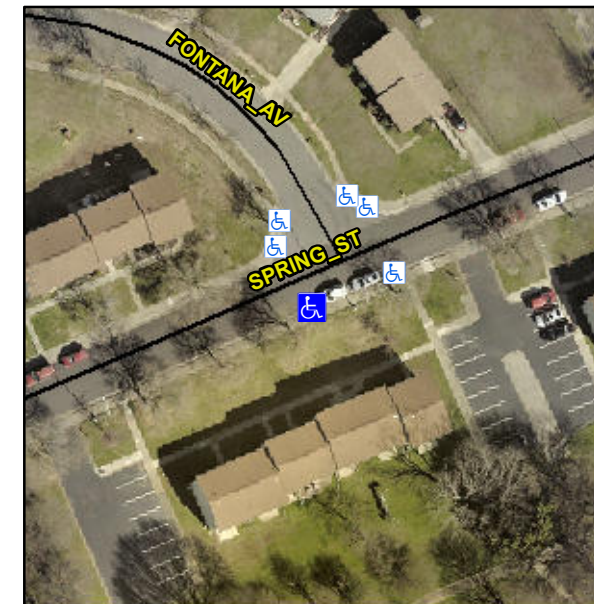
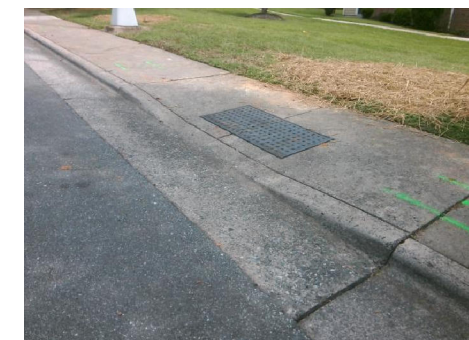
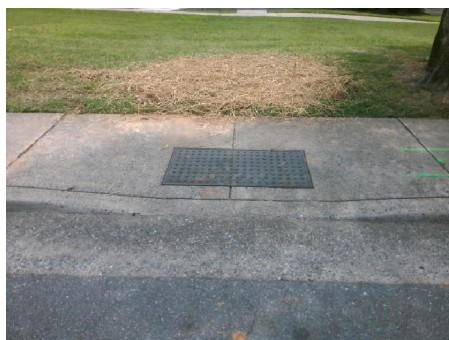
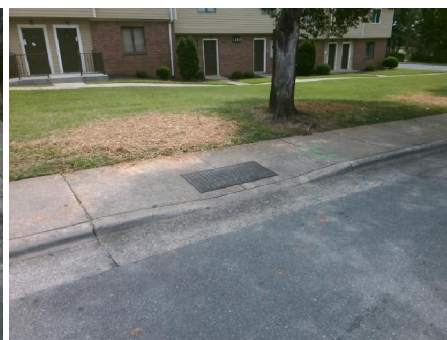
Not Found, R304.2.2, R304.5.3

Compliance	Description	Data	Compliance	Description	Data
N/A	Ramp Length (in)	60.0	No	Ramp Slope (%)	8.8
Yes	Ramp Width (in)	48.0	No	Ramp XSlope (%)	4.1
N/A	Flare Type LT	N/A	N/A	Flare Type RT	N/A
N/A	Flare Slope LT (%)	N/A	N/A	Flare Slope RT (%)	N/A
N/A	Flare Traversable LT?	N/A	N/A	Flare Traversable RT?	N/A
N/A	Landing Length (in)	N/A	N/A	DWS Provided?	N/A
N/A	Landing Width (in)	N/A	N/A	DWS Contrast?	N/A
N/A	Landing Slope (%)	N/A	N/A	DWS Length (in)	N/A
N/A	Landing X Slope (%)	N/A	N/A	DWS Full Width?	N/A
N/A	Landing Curb? (Y/N)	N/A	N/A	DWS Offset (in)	N/A
N/A	Shared Landing?	N/A			
N/A	Gutter Ponding?	N/A	N/A	Gutter Slope (%)	N/A
N/A	Gutter Lip Ht (in)	0.5	N/A	Gutter X Slope (%)	N/A
N/A	Painted X Walk1?	No	N/A	Painted X Walk2?	N/A
	X Walk 1 Direction	To N		X Walk 2 Direction	N/A
N/A	X Walk 1 Width (in)	N/A	N/A	X Walk 2 Width (in)	N/A
	X Walk 1 Slope (%)	1.6		X Walk 2 Slope (%)	N/A
	X Walk 1 X Slope (%)	3.5		X Walk 2 X Slope (%)	N/A

N/A	Ramp inside XWalk1?	N/A	N/A	Ramp inside XWalk2?	N/A
	Road Slope (%)	N/A	N/A	Clear Space?	N/A
	Road X Slope (%)	N/A	N/A	Clear Space to XWalk (in)	N/A
N/A	Any Obstructions?	N/A	N/A	Storm Grate/Utility Hazard?	N/A
	Obstruction Type			Storm Grate/Utility Type	
		N/A			N/A
		Yes		Surface Condition? (G/P)	Good

Possible Solutions:

Remove & Replace Entire Ramp.
