# Access Compliance Report

## Public Rights-of-Way

### (Curb Ramps)

| Intersection ID: 16060 | Main Street: MARSH_RD | Cross Street: MELBOURNE_CT | Location: NW |

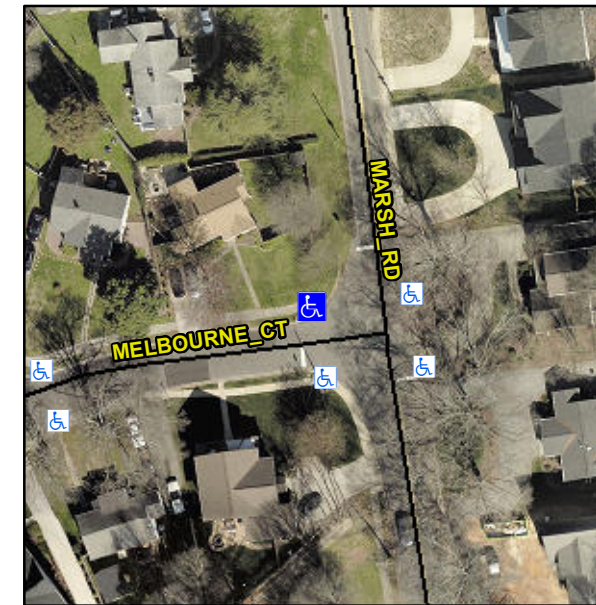
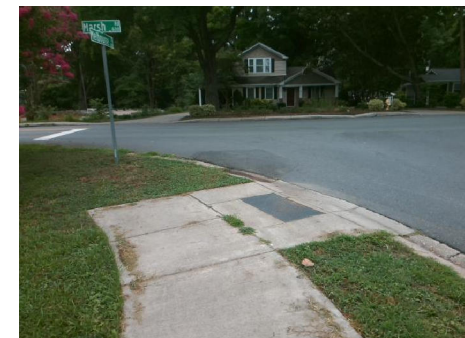
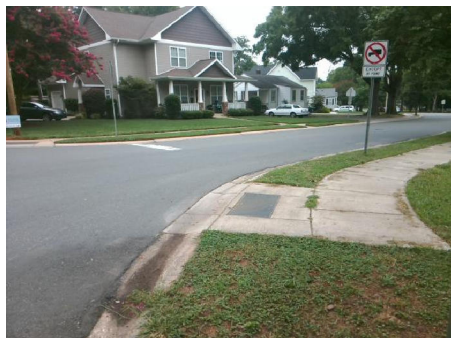
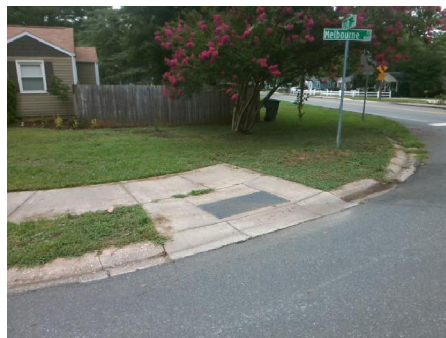
| ADA ID: DD31DD4973EA | Ramp Type: BlendTrans2 | Initial Pass/Fail: Fail | Overall Compliance: No |
| Severity Score: 10 | | | |

**NO LNDG**

**Not Found, R304.5.1, R304.5.3**

| Compliance | Description | Data | Compliance | Description | Data |
|---|---|---|---|---|---|
| No | Ramp Width (in) | 46.5 | No | BlendTrans XSlope (%) | 2.4 |
| | | | No | Curb Slope (%) | 9.6 |

**Remove & Replace Curb Ramp With Two New Directional Ramps or Equivalent.**
