Access Compliance Report Public Rights-of-Way (Curb Ramps)

Intersection ID: 12896 Main Street: E_6TH_ST Cross Street: N_MCDOWELL_ST Location: S

ADA ID: DD35916F22B5 Ramp Type: PerpDiag Initial Pass/Fail: Pass Overall Compliance: No Severity Score: 10.25

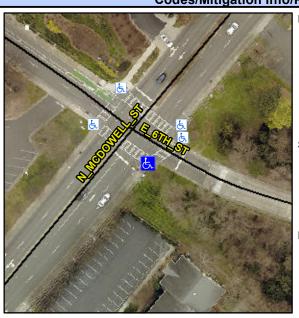
Not Found, R304.5.3, R304.2.1, R304.2.2-Perp, R304.3.2-Para, R305.2

Compliance Description Data Compliance Description Data Yes N/A Ramp Length (in) 73.0 Ramp Slope (%) 7.2 50.0 No Ramp XSlope (%) Yes Ramp Width (in) 2.3 N/A Flare Type LT Sloped N/A Flare Type RT N/A N/A 7.4 Yes Flare Slope RT (%) Flare Slope LT (%) 10.0 N/A Flare Traversable LT? Yes N/A Flare Traversable RT? Yes No N/A Yes DWS Provided? Yes Landing Length (in) No Landing Width (in) N/A Yes **DWS Contrast?** Yes N/A Yes No Landing Slope (%) DWS Length (in) 24.0 No Landing X Slope (%) N/A Yes DWS Full Width? Yes N/A Landing Curb? (Y/N) No No DWS Offset (in) 3.5 N/A Shared Landing? No Gutter Ponding? No Yes Gutter Slope (%) Yes 0.2 Yes Gutter Lip Ht (in) 0.0 Yes Gutter X Slope (%) 1.7 N/A Painted X Walk1? Yes N/A Painted X Walk2? Yes X Walk 1 Direction To NE X Walk 2 Direction To NW N/A 112.0 N/A 108.0 X Walk 1 Width (in) X Walk 2 Width (in) X Walk 1 Slope (%) 1.2 X Walk 2 Slope (%) 2.6 2.5 X Walk 1 X Slope (%) X Walk 2 X Slope (%) 1.9 Yes Ramp inside XWalk2? Yes Ramp inside XWalk1? Yes Yes Road Slope (%) 1.5 N/A Clear Space? Yes Road X Slope (%) 1.0 Yes Clear Space to XWalk (in) 54.0 No Yes Any Obstructions? Yes Storm Grate/Utility Hazard? No **Obstruction Type** Storm Grate/Utility Type N/A N/A

Remove & Replace Curb Ramp With Two New Directional Ramps or Equivalent.
