# Access Compliance Report

## Public Rights-of-Way

### (Curb Ramps)

Intersection ID: 11466	Main Street: BROMWICH_RD	Cross Street: WHITEHALL_DR	Location: NE
ADA ID: DD3B34654672	Ramp Type: Directional1	Initial Pass/Fail: Pass	Overall Compliance: No
Severity Score: 0.25			
Codes/Mitigation Info/Possible Solution		Field Measurements/Component Compliance

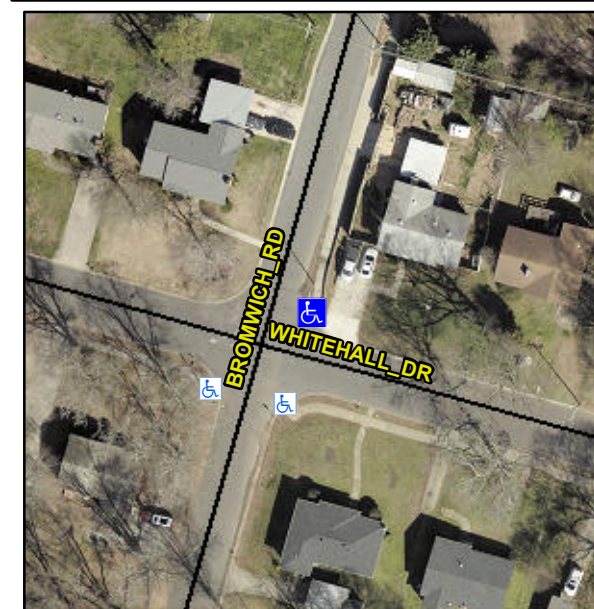
**Not Found, R304.5.3, R305.2, R302.7**

Compliance	Description	Data	Compliance	Description	Data
N/A	Ramp Length (in)	80.0	Yes	Grade Break?	Yes
Yes	Ramp Width (in)	65.0	Yes	Grade Break Slope (%)	1.0
Yes	Ramp Slope (%)	0.4	No	Grade Break XSlope (%)	6.5
Yes	Ramp XSlope (%)	4.2			
N/A	Flare Type LT	N/A	N/A	Flare Type RT	N/A
N/A	Flare Slope LT (%)	16.6	N/A	Flare Slope RT (%)	N/A
N/A	Flare Traversable LT?	No	N/A	Flare Traversable RT?	No
Yes	Landing Length (in)	68.0	Yes	DWS Provided?	Yes
Yes	Landing Width (in)	60.0	Yes	DWS Contrast?	Yes
Yes	Landing Slope (%)	0.9	Yes	DWS Length (in)	25.0
Yes	Landing X Slope (%)	3.0	Yes	DWS Full Width?	Yes
N/A	Landing Curb? (Y/N)	No	Yes	DWS Offset LT (in)	0.0
N/A	Shared Landing?	No	No	DWS Offset RT (in)	66.0
No	Gutter Ponding?	Yes	Yes	Gutter Slope (%)	0.7
Yes	Gutter Lip Ht (in)	0.0	Yes	Gutter X Slope (%)	2.9
N/A	Painted X Walk1?	No		Road Slope (%)	2.9
	X Walk 1 Direction	To S		Road X Slope (%)	4.2
	X Walk 1 Width (in)	N/A		Clear Space?	Yes

X Walk 1 Slope (%)	2.9	N/A	Clear Space to XWalk (in)	N/A
	X Walk 1 X Slope (%)	4.2	Yes	Storm Grate/Utility Hazard?	No
N/A	Ramp inside XWalk1?	N/A		Storm Grate/Utility Type	
Yes	Any Obstructions?	No			N/A
	Obstruction Type		Yes	Surface Condition? (G/P)	Good
			N/A	Curb Slope (%)	10.3

**Remove & Replace Entire Ramp.**

Total Cost: \$ 1600.00
