# Access Compliance Report

## Public Rights-of-Way

### (Curb Ramps)

| Intersection ID: 12080 | Main Street: E_15TH_ST | Cross Street: SEIGLE_AV | Location: W |

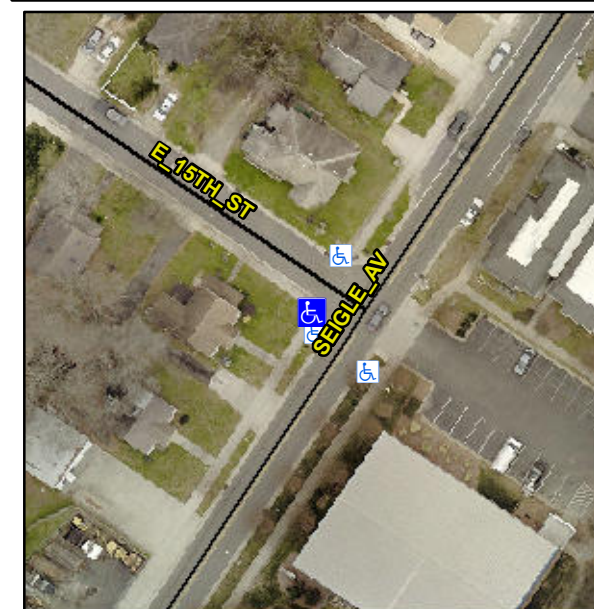
| Compliance | Description | Data | Compliance | Description | Data |
|---|---|---|---|---|---|
| No | Landing Length (in) | N/A | Yes | DWS Provided? | Yes |
| No | Landing Width (in) | N/A | Yes | DWS Contrast? | Yes |
| No | Landing Slope (%) | N/A | Yes | DWS Length (in) | 24.5 |
| No | Landing X Slope (%) | N/A | Yes | DWS Full Width? | Yes |
| Yes | Gutter Ponding? | No | No | Gutter Slope (%) | 5.2 |
| No | Gutter Lip Ht (in) | 2.5 | Yes | Gutter X Slope (%) | 1.5 |

Possible Solutions:

**Install Landing. Remove & Replace Gutter.**
