# Access Compliance Report

## Public Rights-of-Way

### (Curb Ramps)

Intersection ID: N/A	Main Street: E_TRADE_ST	Cross Street: S_COLLEGE_ST	Location: NW
ADA ID: DD48E823EEAE	Ramp Type: Perp	Initial Pass/Fail: Fail	Overall Compliance: No
		Severity Score: 12.5

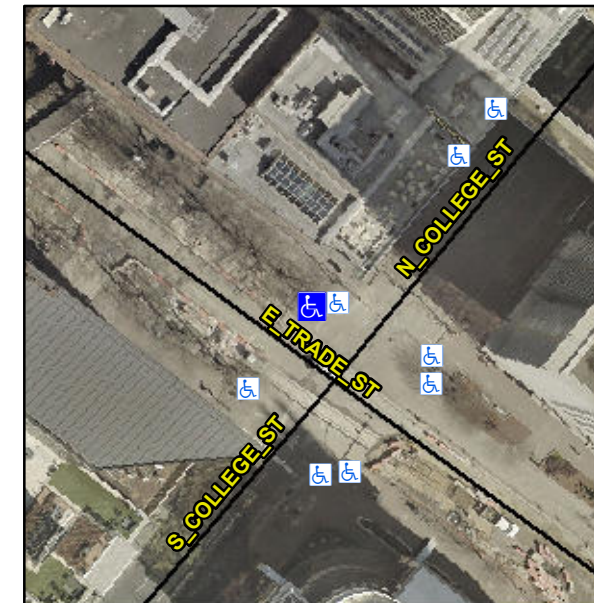
Compliance	Description	Data	Compliance	Description	Data
N/A	Ramp Length (in)	69.0	Yes	Ramp Slope (%)	5.7
Yes	Ramp Width (in)	48.0	No	Ramp XSlope (%)	6.9
N/A	Flare Type LT	N/A	N/A	Flare Type RT	N/A
N/A	Flare Slope LT (%)	N/A	N/A	Flare Slope RT (%)	N/A
N/A	Flare Traversable LT?	N/A	N/A	Flare Traversable RT?	N/A
N/A	Landing Length (in)	N/A	N/A	DWS Provided?	N/A
N/A	Landing Width (in)	N/A	N/A	DWS Contrast?	N/A
N/A	Landing Slope (%)	N/A	N/A	DWS Length (in)	N/A
N/A	Landing X Slope (%)	N/A	N/A	DWS Full Width?	N/A
N/A	Landing Curb? (Y/N)	N/A	N/A	DWS Offset (in)	N/A
N/A	Shared Landing?	N/A			
N/A	Gutter Ponding?	N/A	N/A	Gutter Slope (%)	N/A
N/A	Gutter Lip Ht (in)	N/A	N/A	Gutter X Slope (%)	N/A
N/A	Painted X Walk1?	Yes	N/A	Painted X Walk2?	N/A
	X Walk 1 Direction	To SW		X Walk 2 Direction	N/A
N/A	X Walk 1 Width (in)	123.0	N/A	X Walk 2 Width (in)	N/A
	X Walk 1 Slope (%)	4.2		X Walk 2 Slope (%)	N/A
	X Walk 1 X Slope (%)	3.0		X Walk 2 X Slope (%)	N/A

N/A	Ramp inside XWalk1?	Yes	N/A	Ramp inside XWalk2?	N/A
	Road Slope (%)	N/A	N/A	Clear Space?	N/A
	Road X Slope (%)	N/A	N/A	Clear Space to XWalk (in)	N/A
N/A	Any Obstructions?	N/A	N/A	Storm Grate/Utility Hazard?	N/A
	Obstruction Type			Storm Grate/Utility Type	
		N/A			N/A
			Yes	Surface Condition? (G/P)	Good

**Remove & Replace Entire Ramp.**

**R304.5.3**

Total Cost: \$ 1850.00
