Access Compliance Report

Public Rights-of-Way

(Curb Ramps)

Intersection ID: 10023411		Main Street: CHOATE_CR		Cross Street: N/A		Location:		SE											
ADA ID: DD547DC0D488		Ramp Type: Directional1		Initial Pass/Fail: Pass		Overall Compliance: No		Severity Score: 0											
Codes/Mitigation Info/Possible Solution				Field Measurements/Component Compliance															
<div>

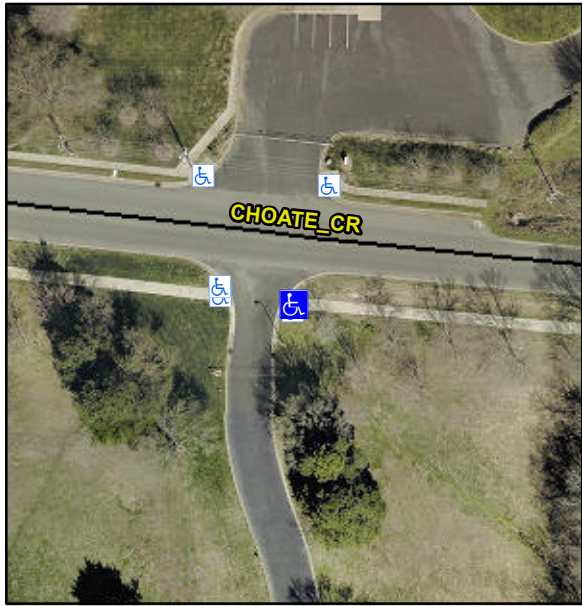
Surveyor Notes:		N/A		N/A		Flare Traversable LT?		No		N/A		Flare Traversable RT?		No	
								Yes		Landing Length (in)		60.0		Yes		DWS Provided?		Yes	
								Yes		Landing Width (in)		72.0		Yes		DWS Contrast?		Yes	
				Yes		Landing Slope (%)		1.9		Yes		DWS Length (in)		24.0					
				Yes		Landing X Slope (%)		1.2		Yes		DWS Full Width?		Yes					
PROW/ADA:		R304.5.3, R305.2		N/A		Landing Curb? (Y/N)		N/A		No		DWS Offset LT (in)		19.5					
				N/A		Shared Landing?		No		Yes		DWS Offset RT (in)		51.0					
				Yes		Gutter Ponding?		No		Yes		Gutter Slope (%)		0.9					
				Yes		Gutter Lip Ht (in)		0.0		No		Gutter X Slope (%)		2.8					
				N/A		Painted X Walk1?		No				Road Slope (%)		1.6					
						X Walk 1 Direction		To SW				Road X Slope (%)		1.3					
						X Walk 1 Width (in)		N/A				Clear Space?		Yes					
						X Walk 1 Slope (%)		1.6		N/A		Clear Space to XWalk (in)		N/A					
						X Walk 1 X Slope (%)		1.3		Yes		Storm Grate/Utility Hazard?		No

N/A		Ramp inside XWalk1?		N/A				Storm Grate/Utility Type							
				Yes		Any Obstructions?		No						N/A					
						Obstruction Type				Yes		Surface Condition? (G/P)		Good					
										N/A		Yes		Curb Slope (%)		5.9			
Total Cost:				\$		2350.00

</div> <div>Street 1 NameENTRANCE</div> <div>Stop Condition-Street 1None</div> <div>Street 2 NameN/A</div> <div>Stop Condition-Street 2N/A</div>				Possible Solutions:		Compliance		Description		Data		Compliance		Description		Data			
				Remove & Replace Entire Ramp.		N/A		Ramp Length (in)		81.0		Yes		Grade Break?		Yes			
				Remove & Replace Gutter.		Yes		Ramp Width (in)		72.0		Yes		Grade Break Slope (%)		0.3			
						Yes		Ramp Slope (%)		4.6		No		Grade Break XSlope (%)		2.3			
						Yes		Ramp XSlope (%)		1.5									
						Yes		Flare Type LT		N/A		Yes		Flare Type RT		N/A			
						N/A		Flare Slope LT (%)		N/A		N/A		Flare Slope RT (%)		N/A
