Access Compliance Report

Public Rights-of-Way

(Curb Ramps)

Intersection ID: 15168	Main Street: ALBEMARLE_RD	Cross Street: STARKWOOD_DR	Location: SE
ADA ID: DD54C332D892	Ramp Type: Para	Initial Pass/Fail: Fail	Overall Compliance: No
Codes/Mitigation Info/Possible Solution		Field Measurements/Component Compliance	
Severity Score: 13.75

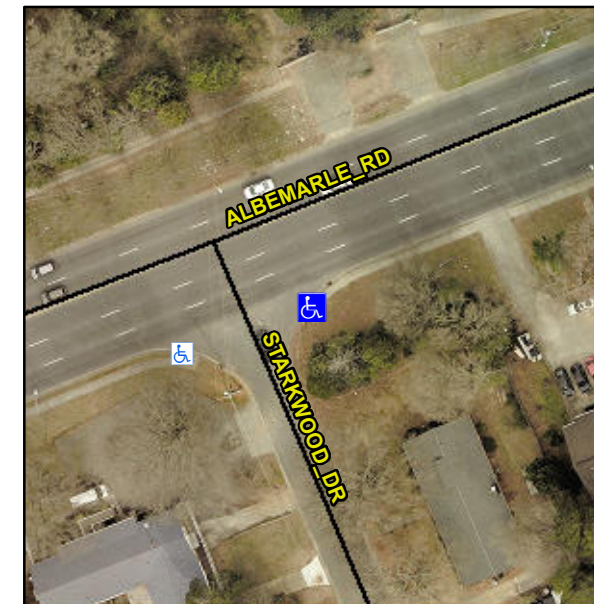
Compliance	Description	Data	Compliance	Description	Data
N/A	Ramp Length LT (in)	64.0	N/A	Ramp Length RT (in)	63.0
Yes	Ramp Width LT (in)	60.0	Yes	Ramp Width RT (in)	60.0
Yes	Ramp Slope LT (%)	5.3	No	Ramp Slope RT (%)	8.4
Yes	Ramp XSlope LT (%)	1.7	No	Ramp XSlope RT (%)	2.2
N/A	Landing Length (in)	N/A	N/A	DWS Provided?	N/A
N/A	Landing Width (in)	N/A	N/A	DWS Contrast?	N/A
N/A	Landing Slope (%)	N/A	N/A	DWS Length (in)	N/A
N/A	Landing X Slope (%)	N/A	N/A	DWS Full Width?	N/A
N/A	Landing Curb? (Y/N)	N/A	N/A	DWS Offset (in)	N/A
N/A	Shared Landing?	N/A			
N/A	Gutter Ponding?	N/A	N/A	Gutter Slope (%)	N/A
N/A	Gutter Lip Ht (in)	2.0	N/A	Gutter X Slope (%)	N/A
N/A	Painted X Walk1?	No	N/A	Painted X Walk2?	N/A
	X Walk 1 Direction	To W		X Walk 2 Direction	N/A
N/A	X Walk 1 Width (in)	N/A	N/A	X Walk 2 Width (in)	N/A
	X Walk 1 Slope (%)	4.2		X Walk 2 Slope (%)	N/A
	X Walk 1 X Slope (%)	1.6		X Walk 2 X Slope (%)	N/A
N/A	Ramp inside XWalk1?	N/A	N/A	Ramp inside XWalk2?	N/A

Road Slope (%)	N/A	N/A	Clear Space?	N/A
	Road X Slope (%)	N/A	N/A	Clear Space to XWalk (in)	N/A
N/A	Any Obstructions?	N/A	N/A	Storm Grate/Utility Hazard?	N/A
	Obstruction Type			Storm Grate/Utility Type	
		N/A			N/A
			Yes	Surface Condition? (G/P)	Good
			N/A	Curb Slope (%)	N/A

Remove & Replace Entire Ramp.
