Access Compliance Report Public Rights-of-Way (Curb Ramps)

Intersection ID: 50580 Main Street: LONGSTRAW_RD Cross Street: PAPER_TREE_RD Location: S

ADA ID: DD5DAF0D1628 Ramp Type: Perp Initial Pass/Fail: Fail Overall Compliance: No Severity Score: 21.25

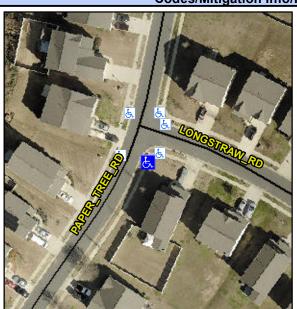
Not Found, R304.5.1, R304.2.2

Compliance Description <u>Data</u> Compliance Description Data No N/A Ramp Length (in) 48.0 Ramp Slope (%) 8.5 Yes Ramp XSlope (%) No Ramp Width (in) 47.0 8.0 N/A N/A Flare Type LT N/A Flare Type RT N/A N/A N/A N/A Flare Slope RT (%) N/A Flare Slope LT (%) N/A Flare Traversable LT? N/A N/A Flare Traversable RT? N/A N/A N/A N/A **DWS Provided?** N/A Landing Length (in) N/A Landing Width (in) N/A N/A **DWS Contrast?** N/A N/A N/A N/A Landing Slope (%) DWS Length (in) N/A N/A Landing X Slope (%) N/A N/A DWS Full Width? N/A N/A Landing Curb? (Y/N) N/A N/A DWS Offset (in) N/A N/A N/A Shared Landing? N/A **Gutter Ponding?** N/A N/A Gutter Slope (%) N/A N/A Gutter Lip Ht (in) N/A N/A Gutter X Slope (%) N/A N/A Painted X Walk1? No N/A Painted X Walk2? N/A X Walk 1 Direction To NW X Walk 2 Direction N/A N/A N/A N/A X Walk 1 Width (in) X Walk 2 Width (in) N/A X Walk 1 Slope (%) 1.5 X Walk 2 Slope (%) N/A X Walk 1 X Slope (%) 1.0 X Walk 2 X Slope (%) N/A N/A N/A N/A Ramp inside XWalk2? Ramp inside XWalk1? N/A Road Slope (%) N/A N/A Clear Space? N/A N/A Road X Slope (%) N/A Clear Space to XWalk (in) N/A N/A N/A Any Obstructions? N/A Storm Grate/Utility Hazard? N/A **Obstruction Type** Storm Grate/Utility Type N/A N/A Yes Surface Condition? (G/P) Good

Remove & Replace Entire Ramp.

Total Cost: \$ 1850.00
