Access Compliance Report

Public Rights-of-Way

(Curb Ramps)

Intersection ID: 10023159	Main Street: CHARLOTTE_VIEW_DR	Cross Street: N/A	Location: NW
ADA ID: DD66C46A4E0F	Ramp Type: PerpDiag	Initial Pass/Fail: Fail	Overall Compliance: No
Codes/Mitigation Info/Possible Solution		Field Measurements/Component Compliance

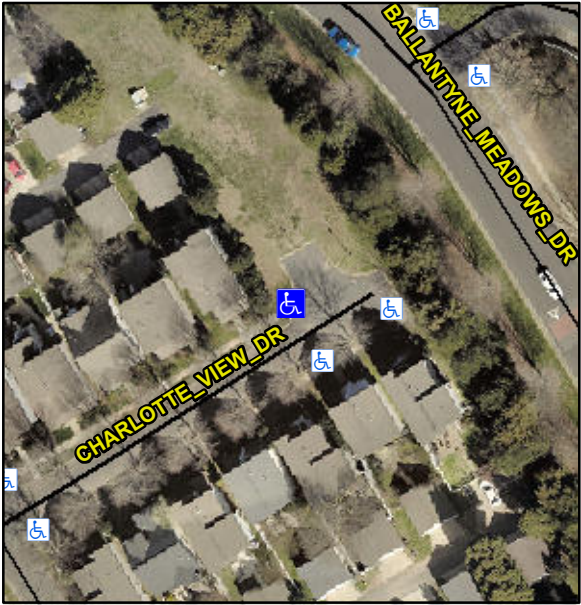
Compliance	Description	Data	Compliance	Description	Data
N/A	Ramp Length (in)	40.0	No	Ramp Slope (%)	10.7
Yes	Ramp Width (in)	48.0	Yes	Ramp XSlope (%)	1.9
N/A	Flare Type LT	N/A	N/A	Flare Type RT	N/A
N/A	Flare Slope LT (%)	N/A	N/A	Flare Slope RT (%)	N/A
N/A	Flare Traversable LT?	N/A	N/A	Flare Traversable RT?	N/A
N/A	Landing Length (in)	N/A	N/A	DWS Provided?	N/A
N/A	Landing Width (in)	N/A	N/A	DWS Contrast?	N/A
N/A	Landing Slope (%)	N/A	N/A	DWS Length (in)	N/A
N/A	Landing X Slope (%)	N/A	N/A	DWS Full Width?	N/A
N/A	Landing Curb? (Y/N)	N/A	N/A	DWS Offset (in)	N/A
N/A	Shared Landing?	N/A			
N/A	Gutter Ponding?	N/A	N/A	Gutter Slope (%)	N/A
N/A	Gutter Lip Ht (in)	N/A	N/A	Gutter X Slope (%)	N/A
N/A	Painted X Walk1?	No	N/A	Painted X Walk2?	No
	X Walk 1 Direction	To SE		X Walk 2 Direction	To NE
N/A	X Walk 1 Width (in)	N/A	N/A	X Walk 2 Width (in)	N/A
	X Walk 1 Slope (%)	1.3		X Walk 2 Slope (%)	2.8
	X Walk 1 X Slope (%)	2.6		X Walk 2 X Slope (%)	0.6

N/A	Ramp inside XWalk1?	N/A	N/A	Ramp inside XWalk2?	N/A
	Road Slope (%)	2.2	N/A	Clear Space?	N/A
	Road X Slope (%)	2.8	N/A	Clear Space to XWalk (in)	N/A
N/A	Any Obstructions?	N/A	N/A	Storm Grate/Utility Hazard?	N/A
	Obstruction Type			Storm Grate/Utility Type	
		N/A			N/A
			Yes	Surface Condition? (G/P)	Good

Possible Solutions:			
	Remove & Replace Curb Ramp With Two New Directional Ramps or Equivalent.			
	Surveyor Notes:			
	N/A			
	PROW/ADA:			
	R304.2.2			
Street 1 Name	CHARLOTTE VIEW DR			
Stop Condition-Street 2	None			
Street 2 Name	N/A			
Stop Condition-Street 1	None			
Total Cost:		\$	3200.00
