Access Compliance Report

Public Rights-of-Way

(Curb Ramps)

Intersection ID: 10037286	Main Street: SARDIS_RD_NORTH	Cross Street: N/A	Location: SE
ADA ID: DD7542B99F89	Ramp Type: Perp	Initial Pass/Fail: Fail	Overall Compliance: No
Severity Score: 22.5			
Codes/Mitigation Info/Possible Solution		Field Measurements/Component Compliance

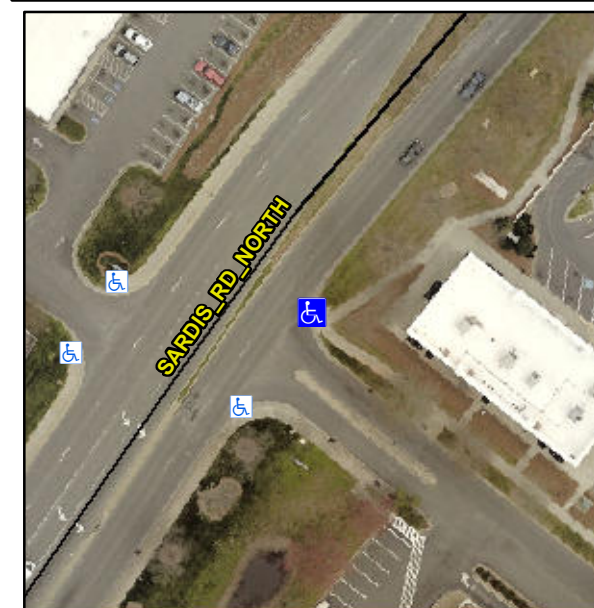
Not Found, R304.5.1, R304.2.2, R304.5.3

Compliance	Description	Data	Compliance	Description	Data
N/A	Ramp Length (in)	36.0	No	Ramp Slope (%)	11.4
No	Ramp Width (in)	39.0	No	Ramp XSlope (%)	2.7
N/A	Flare Type LT	N/A	N/A	Flare Type RT	N/A
N/A	Flare Slope LT (%)	N/A	N/A	Flare Slope RT (%)	N/A
N/A	Flare Traversable LT?	N/A	N/A	Flare Traversable RT?	N/A
N/A	Landing Length (in)	N/A	N/A	DWS Provided?	N/A
N/A	Landing Width (in)	N/A	N/A	DWS Contrast?	N/A
N/A	Landing Slope (%)	N/A	N/A	DWS Length (in)	N/A
N/A	Landing X Slope (%)	N/A	N/A	DWS Full Width?	N/A
N/A	Landing Curb? (Y/N)	N/A	N/A	DWS Offset (in)	N/A
N/A	Shared Landing?	N/A			
N/A	Gutter Ponding?	N/A	N/A	Gutter Slope (%)	N/A
N/A	Gutter Lip Ht (in)	N/A	N/A	Gutter X Slope (%)	N/A
N/A	Painted X Walk1?	No	N/A	Painted X Walk2?	N/A
	X Walk 1 Direction	To SW		X Walk 2 Direction	N/A
N/A	X Walk 1 Width (in)	N/A	N/A	X Walk 2 Width (in)	N/A
	X Walk 1 Slope (%)	1.7		X Walk 2 Slope (%)	N/A
	X Walk 1 X Slope (%)	1.6		X Walk 2 X Slope (%)	N/A

N/A	Ramp inside XWalk1?	N/A	N/A	Ramp inside XWalk2?	N/A
	Road Slope (%)	N/A	N/A	Clear Space?	N/A
	Road X Slope (%)	N/A	N/A	Clear Space to XWalk (in)	N/A
N/A	Any Obstructions?	N/A	N/A	Storm Grate/Utility Hazard?	N/A
	Obstruction Type			Storm Grate/Utility Type	
		N/A			N/A
			Yes	Surface Condition? (G/P)	Good

Possible Solutions:

Remove & Replace Entire Ramp.
