# Access Compliance Report

## Public Rights-of-Way

### (Curb Ramps)

Intersection ID: 26197	Main Street: PARK_RD	Cross Street: TREEBARK_DR	Location: NW
ADA ID: DD894980B440	Ramp Type: PerpDiag	Initial Pass/Fail: Fail	Overall Compliance: No
Severity Score: 33.75			
Codes/Mitigation Info/Possible Solution		Field Measurements/Component Compliance

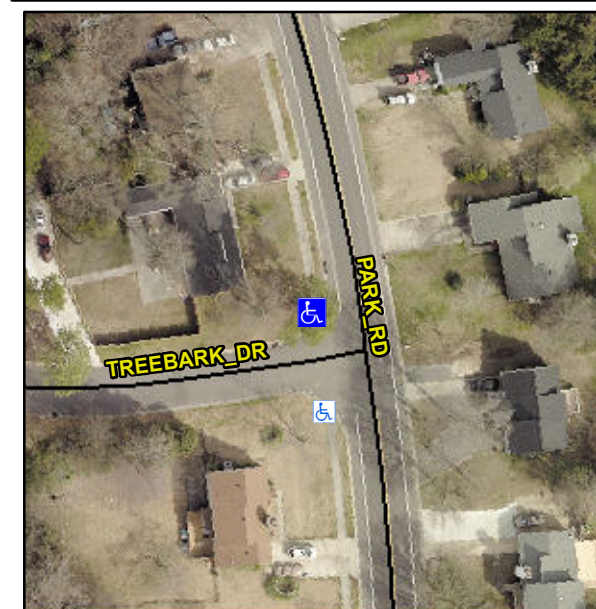
Compliance	Description	Data	Compliance	Description	Data
N/A	Ramp Length (in)	70.0	No	Ramp Slope (%)	9.6
No	Ramp Width (in)	47.0	No	Ramp XSlope (%)	6.8
N/A	Flare Type LT	N/A	N/A	Flare Type RT	N/A
N/A	Flare Slope LT (%)	N/A	N/A	Flare Slope RT (%)	N/A
N/A	Flare Traversable LT?	N/A	N/A	Flare Traversable RT?	N/A
N/A	Landing Length (in)	N/A	N/A	DWS Provided?	N/A
N/A	Landing Width (in)	N/A	N/A	DWS Contrast?	N/A
N/A	Landing Slope (%)	N/A	N/A	DWS Length (in)	N/A
N/A	Landing X Slope (%)	N/A	N/A	DWS Full Width?	N/A
N/A	Landing Curb? (Y/N)	N/A	N/A	DWS Offset (in)	N/A
N/A	Shared Landing?	N/A			
N/A	Gutter Ponding?	N/A	N/A	Gutter Slope (%)	N/A
N/A	Gutter Lip Ht (in)	N/A	N/A	Gutter X Slope (%)	N/A
N/A	Painted X Walk1?	No	N/A	Painted X Walk2?	No
	X Walk 1 Direction	To S		X Walk 2 Direction	To E
N/A	X Walk 1 Width (in)	N/A	N/A	X Walk 2 Width (in)	N/A
	X Walk 1 Slope (%)	3.5		X Walk 2 Slope (%)	0.1
	X Walk 1 X Slope (%)	1.2		X Walk 2 X Slope (%)	2.4

N/A	Ramp inside XWalk1?	N/A	N/A	Ramp inside XWalk2?	N/A
	Road Slope (%)	4.3	N/A	Clear Space?	N/A
	Road X Slope (%)	0.3	N/A	Clear Space to XWalk (in)	N/A
N/A	Any Obstructions?	N/A	N/A	Storm Grate/Utility Hazard?	N/A
	Obstruction Type			Storm Grate/Utility Type	
		N/A			N/A
			Yes	Surface Condition? (G/P)	Good

Possible Solutions:

**Remove & Replace Curb Ramp With Two New Directional Ramps or Equivalent.**

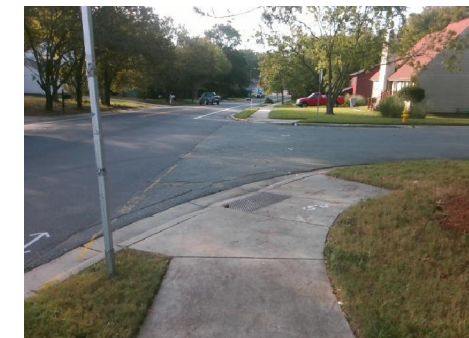
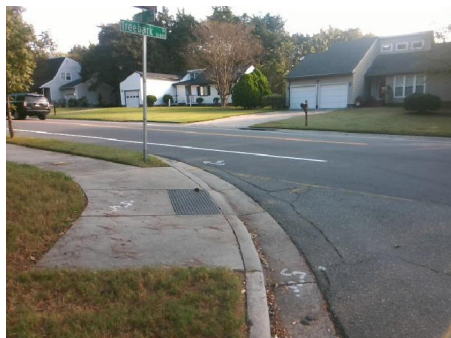
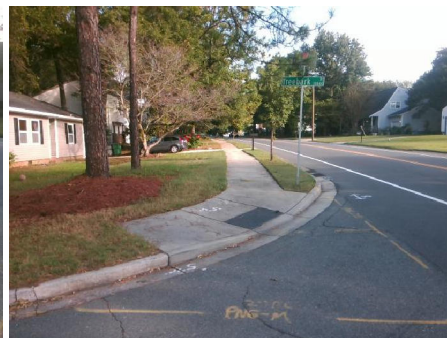
Street 1 Name TREEBARK DR  
 Stop Condition-Street 2 StopSign  
 Street 2 Name PARK RD  
 Stop Condition-Street 1 None
