# Access Compliance Report

## Public Rights-of-Way

### (Curb Ramps)

Intersection ID: 13277	Main Street: SPRUCE_ST	Cross Street: WILMORE_DR	Location: NE
ADA ID: DD8F73F0C5D5	Ramp Type: PerpDiag	Initial Pass/Fail: Fail	Overall Compliance: No
		Severity Score: 25

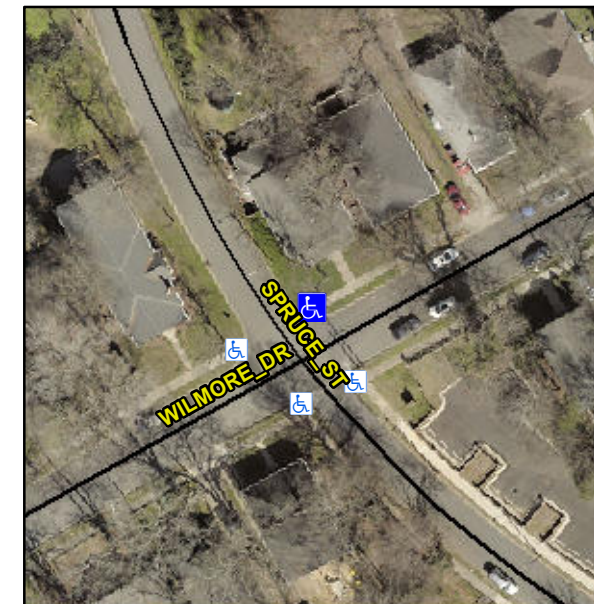
**Not Found, R304.2.2, R304.5.3**

Compliance	Description	Data	Compliance	Description	Data
N/A	Ramp Length (in)	41.0	No	Ramp Slope (%)	10.4
Yes	Ramp Width (in)	48.0	No	Ramp XSlope (%)	6.9
N/A	Flare Type LT	N/A	N/A	Flare Type RT	N/A
N/A	Flare Slope LT (%)	N/A	N/A	Flare Slope RT (%)	N/A
N/A	Flare Traversable LT?	N/A	N/A	Flare Traversable RT?	N/A
N/A	Landing Length (in)	N/A	N/A	DWS Provided?	N/A
N/A	Landing Width (in)	N/A	N/A	DWS Contrast?	N/A
N/A	Landing Slope (%)	N/A	N/A	DWS Length (in)	N/A
N/A	Landing X Slope (%)	N/A	N/A	DWS Full Width?	N/A
N/A	Landing Curb? (Y/N)	N/A	N/A	DWS Offset (in)	N/A
N/A	Shared Landing?	N/A			
N/A	Gutter Ponding?	N/A	N/A	Gutter Slope (%)	N/A
N/A	Gutter Lip Ht (in)	1.0	N/A	Gutter X Slope (%)	N/A
N/A	Painted X Walk1?	No	N/A	Painted X Walk2?	No
	X Walk 1 Direction	To SW		X Walk 2 Direction	To SE
N/A	X Walk 1 Width (in)	N/A	N/A	X Walk 2 Width (in)	N/A
	X Walk 1 Slope (%)	0.8		X Walk 2 Slope (%)	2.0
	X Walk 1 X Slope (%)	4.0		X Walk 2 X Slope (%)	3.0

N/A	Ramp inside XWalk1?	N/A	N/A	Ramp inside XWalk2?	N/A
	Road Slope (%)	3.6	N/A	Clear Space?	N/A
	Road X Slope (%)	4.5	N/A	Clear Space to XWalk (in)	N/A
N/A	Any Obstructions?	N/A	N/A	Storm Grate/Utility Hazard?	N/A
	Obstruction Type			Storm Grate/Utility Type	
		N/A			N/A
			Yes	Surface Condition? (G/P)	Good

**Remove & Replace Curb Ramp With Two New Directional Ramps or Equivalent.**

Total Cost: \$ 3200.00
