# Access Compliance Report

## Public Rights-of-Way

### (Curb Ramps)

Intersection ID: 6421	Main Street: S_SHOPPING_CENTER_DR	Cross Street: UNIVERSITY_CITY_BV	Location: SE
ADA ID: DD98B0677286	Ramp Type: Perp	Initial Pass/Fail: Fail	Overall Compliance: No
Codes/Mitigation Info/Possible Solution			Severity Score: 25
			Field Measurements/Component Compliance

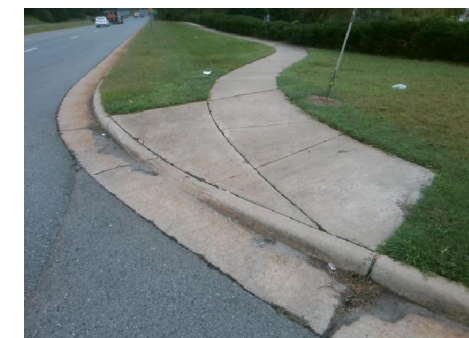
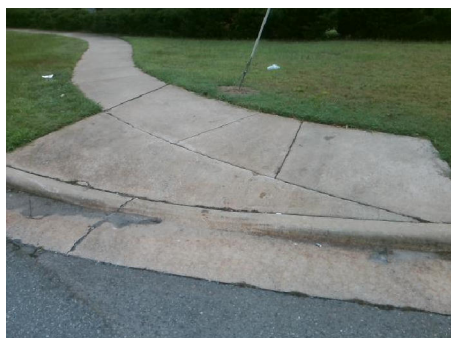
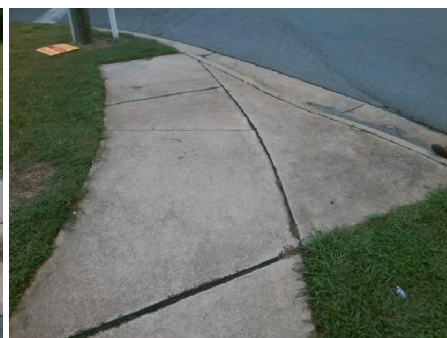
Compliance	Description	Data	Compliance	Description	Data
N/A	Ramp Length (in)	32.5	No	Ramp Slope (%)	16.2
Yes	Ramp Width (in)	48.0	Yes	Ramp XSlope (%)	1.5
N/A	Flare Type LT	N/A	N/A	Flare Type RT	N/A
N/A	Flare Slope LT (%)	N/A	N/A	Flare Slope RT (%)	N/A
N/A	Flare Traversable LT?	N/A	N/A	Flare Traversable RT?	N/A
N/A	Landing Length (in)	N/A	N/A	DWS Provided?	N/A
N/A	Landing Width (in)	N/A	N/A	DWS Contrast?	N/A
N/A	Landing Slope (%)	N/A	N/A	DWS Length (in)	N/A
N/A	Landing X Slope (%)	N/A	N/A	DWS Full Width?	N/A
N/A	Landing Curb? (Y/N)	N/A	N/A	DWS Offset (in)	N/A
N/A	Shared Landing?	N/A			
N/A	Gutter Ponding?	N/A	N/A	Gutter Slope (%)	N/A
N/A	Gutter Lip Ht (in)	N/A	N/A	Gutter X Slope (%)	N/A
N/A	Painted X Walk1?	No	N/A	Painted X Walk2?	N/A
	X Walk 1 Direction	To N		X Walk 2 Direction	N/A
N/A	X Walk 1 Width (in)	N/A	N/A	X Walk 2 Width (in)	N/A
	X Walk 1 Slope (%)	5.5		X Walk 2 Slope (%)	N/A
	X Walk 1 X Slope (%)	4.0		X Walk 2 X Slope (%)	N/A

N/A	Ramp inside XWalk1?	N/A	N/A	Ramp inside XWalk2?	N/A
	Road Slope (%)	N/A	N/A	Clear Space?	N/A
	Road X Slope (%)	N/A	N/A	Clear Space to XWalk (in)	N/A
N/A	Any Obstructions?	N/A	N/A	Storm Grate/Utility Hazard?	N/A
	Obstruction Type			Storm Grate/Utility Type	
		N/A			N/A
			Yes	Surface Condition? (G/P)	Good

**Remove & Replace Entire Ramp.**

Total Cost: \$ 1850.00
