Access Compliance Report

Public Rights-of-Way

(Curb Ramps)

Intersection ID: 30279	Main Street: HAMPTON WAY DR	Cross Street: REAGAN DR	Location: SW
ADA ID: DD992F98C619	Ramp Type: Perp	Initial Pass/Fail: Fail	Overall Compliance: No
Severity Score: 22.5			
Codes/Mitigation Info/Possible Solution		Field Measurements/Component Compliance

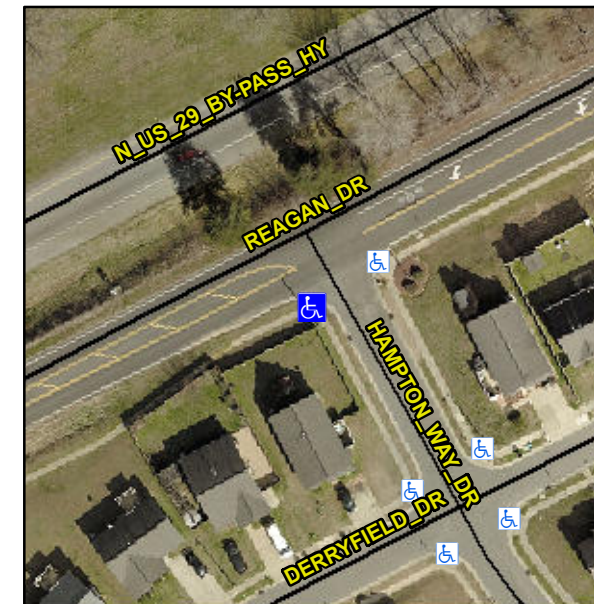
Not Found, R304.5.1, R304.2.2, R304.5.3

Compliance	Description	Data	Compliance	Description	Data
N/A	Ramp Length (in)	45.0	No	Ramp Slope (%)	8.8
No	Ramp Width (in)	39.0	No	Ramp XSlope (%)	2.5
N/A	Flare Type LT	N/A	N/A	Flare Type RT	N/A
N/A	Flare Slope LT (%)	N/A	N/A	Flare Slope RT (%)	N/A
N/A	Flare Traversable LT?	N/A	N/A	Flare Traversable RT?	N/A
N/A	Landing Length (in)	N/A	N/A	DWS Provided?	N/A
N/A	Landing Width (in)	N/A	N/A	DWS Contrast?	N/A
N/A	Landing Slope (%)	N/A	N/A	DWS Length (in)	N/A
N/A	Landing X Slope (%)	N/A	N/A	DWS Full Width?	N/A
N/A	Landing Curb? (Y/N)	N/A	N/A	DWS Offset (in)	N/A
N/A	Shared Landing?	N/A			
N/A	Gutter Ponding?	N/A	N/A	Gutter Slope (%)	N/A
N/A	Gutter Lip Ht (in)	N/A	N/A	Gutter X Slope (%)	N/A
N/A	Painted X Walk1?	No	N/A	Painted X Walk2?	N/A
	X Walk 1 Direction	To E		X Walk 2 Direction	N/A
N/A	X Walk 1 Width (in)	N/A	N/A	X Walk 2 Width (in)	N/A
	X Walk 1 Slope (%)	0.5		X Walk 2 Slope (%)	N/A
	X Walk 1 X Slope (%)	1.3		X Walk 2 X Slope (%)	N/A

Possible Solutions:

Remove & Replace Entire Ramp.
