Access Compliance Report

Public Rights-of-Way

(Curb Ramps)

Intersection ID: 43761	Main Street: DERVISH_LN	Cross Street: BIRCHCROFT_LN	Location: NW
ADA ID: DDA07309D8E3	Ramp Type: PerpDiag	Initial Pass/Fail: Pass	Overall Compliance: No
Severity Score: 20			
Codes/Mitigation Info/Possible Solution		Field Measurements/Component Compliance

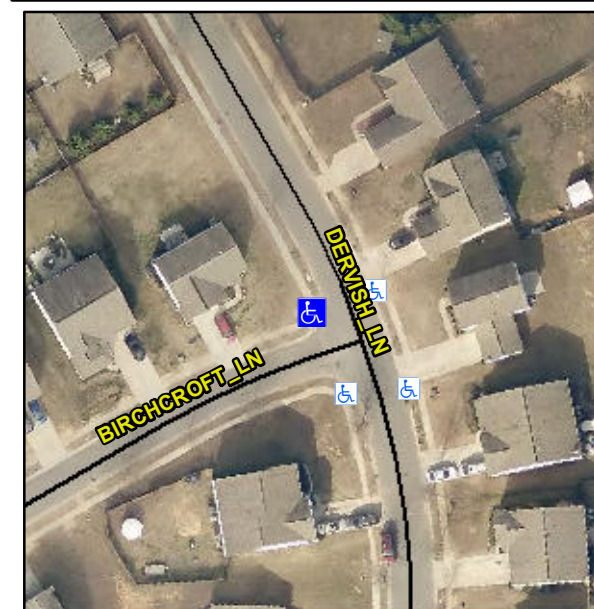
Not Found, R304.2.1, R304.2.2-Perp, R304.3.2-Para, R304.5.3, R305

Compliance	Description	Data	Compliance	Description	Data
N/A	Ramp Length (in)	48.5	Yes	Ramp Slope (%)	6.2
Yes	Ramp Width (in)	55.0	Yes	Ramp XSlope (%)	0.9
N/A	Flare Type LT	Sloped	N/A	Flare Type RT	N/A
N/A	Flare Slope LT (%)	2.2	Yes	Flare Slope RT (%)	0.6
N/A	Flare Traversable LT?	Yes	N/A	Flare Traversable RT?	Yes
No	Landing Length (in)	N/A	No	DWS Provided?	No
No	Landing Width (in)	N/A	N/A	DWS Contrast?	No
No	Landing Slope (%)	N/A	N/A	DWS Length (in)	N/A
No	Landing X Slope (%)	N/A	N/A	DWS Full Width?	No
N/A	Landing Curb? (Y/N)	No	N/A	DWS Offset (in)	N/A
N/A	Shared Landing?	No			
Yes	Gutter Ponding?	No	Yes	Gutter Slope (%)	0.8
Yes	Gutter Lip Ht (in)	0.0	Yes	Gutter X Slope (%)	0.1
N/A	Painted X Walk1?	No	N/A	Painted X Walk2?	No
	X Walk 1 Direction	To S		X Walk 2 Direction	To E
N/A	X Walk 1 Width (in)	N/A	N/A	X Walk 2 Width (in)	N/A
	X Walk 1 Slope (%)	0.2		X Walk 2 Slope (%)	2.2
	X Walk 1 X Slope (%)	0.3		X Walk 2 X Slope (%)	1.7

N/A	Ramp inside XWalk1?	N/A	N/A	Ramp inside XWalk2?	N/A
	Road Slope (%)	0.2	N/A	Clear Space?	Yes
	Road X Slope (%)	5.6	N/A	Clear Space to XWalk (in)	N/A
Yes	Any Obstructions?	No	Yes	Storm Grate/Utility Hazard?	No
	Obstruction Type			Storm Grate/Utility Type	
		N/A			N/A
			Yes	Surface Condition? (G/P)	Good

Remove & Replace Curb Ramp With Two New Directional Ramps or Equivalent.
