Access Compliance Report

Public Rights-of-Way

(Curb Ramps)

Intersection ID: 19299	Main Street: ROCKY_FALLS_RD	Cross Street: THERMAL_RD	Location: SW
ADA ID: DDA7ECB0C871	Ramp Type: PerpDiag	Initial Pass/Fail: Fail	Overall Compliance: No
		Severity Score: 12.5

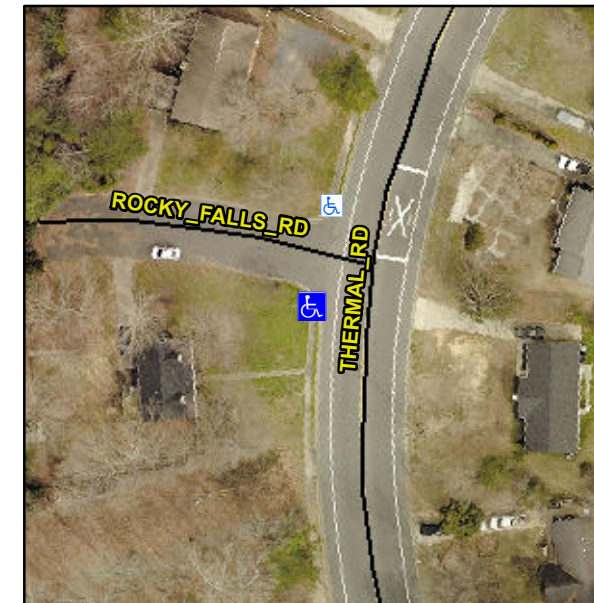
Not Found, R304.5.3

Compliance	Description	Data	Compliance	Description	Data
N/A	Ramp Length (in)	36.0	Yes	Ramp Slope (%)	7.9
Yes	Ramp Width (in)	48.0	No	Ramp XSlope (%)	5.7
N/A	Flare Type LT	N/A	N/A	Flare Type RT	N/A
N/A	Flare Slope LT (%)	N/A	N/A	Flare Slope RT (%)	N/A
N/A	Flare Traversable LT?	N/A	N/A	Flare Traversable RT?	N/A
N/A	Landing Length (in)	N/A	N/A	DWS Provided?	N/A
N/A	Landing Width (in)	N/A	N/A	DWS Contrast?	N/A
N/A	Landing Slope (%)	N/A	N/A	DWS Length (in)	N/A
N/A	Landing X Slope (%)	N/A	N/A	DWS Full Width?	N/A
N/A	Landing Curb? (Y/N)	N/A	N/A	DWS Offset (in)	N/A
N/A	Shared Landing?	N/A			
N/A	Gutter Ponding?	N/A	N/A	Gutter Slope (%)	N/A
N/A	Gutter Lip Ht (in)	N/A	N/A	Gutter X Slope (%)	N/A
N/A	Painted X Walk1?	No	N/A	Painted X Walk2?	No
	X Walk 1 Direction	To SE		X Walk 2 Direction	To NE
N/A	X Walk 1 Width (in)	N/A	N/A	X Walk 2 Width (in)	N/A
	X Walk 1 Slope (%)	3.6		X Walk 2 Slope (%)	11.7
	X Walk 1 X Slope (%)	9.9		X Walk 2 X Slope (%)	9.3

N/A	Ramp inside XWalk1?	N/A	N/A	Ramp inside XWalk2?	N/A
	Road Slope (%)	5.7	N/A	Clear Space?	N/A
	Road X Slope (%)	10.1	N/A	Clear Space to XWalk (in)	N/A
N/A	Any Obstructions?	N/A	N/A	Storm Grate/Utility Hazard?	N/A
	Obstruction Type			Storm Grate/Utility Type	
		N/A			N/A
		Yes		Surface Condition? (G/P)	Good

Remove & Replace Curb Ramp With Two New Directional Ramps or Equivalent.

Total Cost: \$ 3200.00
