Access Compliance Report

Public Rights-of-Way

(Curb Ramps)

Intersection ID: 15125	Main Street: CHEROKEE_RD	Cross Street: PROVIDENCE_RD	Location: NE
ADA ID: DDA82238BDC3	Ramp Type: PerpDiag	Initial Pass/Fail: Fail	Overall Compliance: No
			Severity Score: 33.75

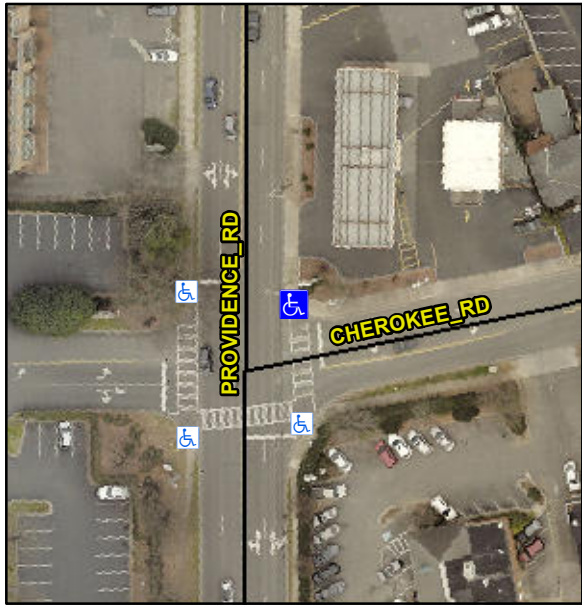
Possible Solutions:		Compliance	Description	Data	Compliance	Description	Data
	Remove & Replace Curb Ramp With Two New Directional Ramps or Equivalent.		N/A	Ramp Length (in)	80.0	No	Ramp Slope (%)	8.7
			No	Ramp Width (in)	47.0	No	Ramp XSlope (%)	5.8
			N/A	Flare Type LT	N/A	N/A	Flare Type RT	N/A
			N/A	Flare Slope LT (%)	N/A	N/A	Flare Slope RT (%)	N/A
			N/A	Flare Traversable LT?	N/A	N/A	Flare Traversable RT?	N/A
			N/A	Landing Length (in)	N/A	N/A	DWS Provided?	N/A
			N/A	Landing Width (in)	N/A	N/A	DWS Contrast?	N/A
			N/A	Landing Slope (%)	N/A	N/A	DWS Length (in)	N/A
			N/A	Landing X Slope (%)	N/A	N/A	DWS Full Width?	N/A
Surveyor Notes:	N/A		N/A	Landing Curb? (Y/N)	N/A	N/A	DWS Offset (in)	N/A
			N/A	Shared Landing?	N/A			
	PROW/ADA:		N/A	Gutter Ponding?	N/A	N/A	Gutter Slope (%)	N/A
	Not Found, R304.5.1, R304.2.2, R304.5.3		N/A	Gutter Lip Ht (in)	N/A	N/A	Gutter X Slope (%)	N/A

N/A	Painted X Walk1?	No	N/A	Painted X Walk2?	Yes
				X Walk 1 Direction	To W		X Walk 2 Direction	To S
			N/A	X Walk 1 Width (in)	N/A	N/A	X Walk 2 Width (in)	104.0
				X Walk 1 Slope (%)	9.3		X Walk 2 Slope (%)	3.7
				X Walk 1 X Slope (%)	2.1		X Walk 2 X Slope (%)	7.4
			N/A	Ramp inside XWalk1?	N/A	N/A	Ramp inside XWalk2?	Yes
			Road Slope (%)	4.1	N/A	Clear Space?	N/A	
			Road X Slope (%)	10.7	N/A	Clear Space to XWalk (in)	N/A	
		N/A	Any Obstructions?	N/A	N/A	Storm Grate/Utility Hazard?	N/A	
			Obstruction Type			Storm Grate/Utility Type		
					N/A			N/A
						Yes	Surface Condition? (G/P)	Good
