Access Compliance Report

Public Rights-of-Way

(Curb Ramps)

Intersection ID: 44207	Main Street: MOCKERNUT_DR	Cross Street: TARTARIAN_CT	Location: NW
ADA ID: DDAD164C3DD3	Ramp Type: PerpDiag	Initial Pass/Fail: Fail	Overall Compliance: No
		Severity Score: 8.75

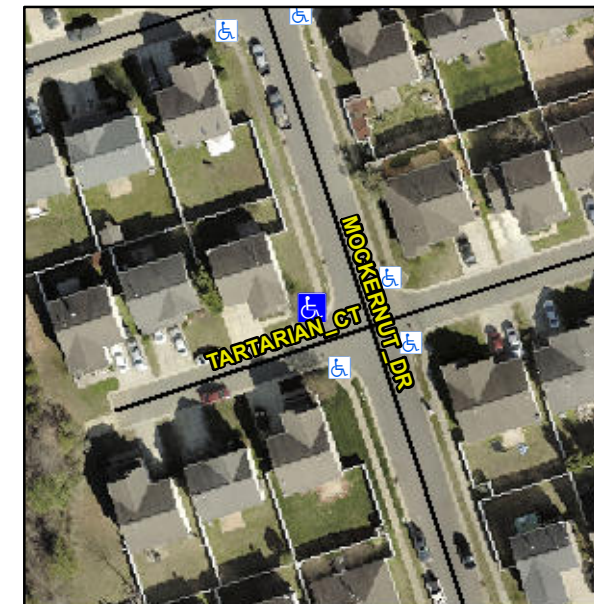
Not Found, R304.5.1

Compliance	Description	Data	Compliance	Description	Data
N/A	Ramp Length (in)	48.5	Yes	Ramp Slope (%)	6.1
No	Ramp Width (in)	47.0	Yes	Ramp XSlope (%)	1.7
N/A	Flare Type LT	N/A	N/A	Flare Type RT	N/A
N/A	Flare Slope LT (%)	N/A	N/A	Flare Slope RT (%)	N/A
N/A	Flare Traversable LT?	N/A	N/A	Flare Traversable RT?	N/A
N/A	Landing Length (in)	N/A	N/A	DWS Provided?	N/A
N/A	Landing Width (in)	N/A	N/A	DWS Contrast?	N/A
N/A	Landing Slope (%)	N/A	N/A	DWS Length (in)	N/A
N/A	Landing X Slope (%)	N/A	N/A	DWS Full Width?	N/A
N/A	Landing Curb? (Y/N)	N/A	N/A	DWS Offset (in)	N/A
N/A	Shared Landing?	N/A			
N/A	Gutter Ponding?	Yes	N/A	Gutter Slope (%)	N/A
N/A	Gutter Lip Ht (in)	N/A	N/A	Gutter X Slope (%)	N/A
N/A	Painted X Walk1?	No	N/A	Painted X Walk2?	No
	X Walk 1 Direction	To S		X Walk 2 Direction	To E
N/A	X Walk 1 Width (in)	N/A	N/A	X Walk 2 Width (in)	N/A
	X Walk 1 Slope (%)	6.3		X Walk 2 Slope (%)	3.2
	X Walk 1 X Slope (%)	1.0		X Walk 2 X Slope (%)	5.1

N/A	Ramp inside XWalk1?	N/A	N/A	Ramp inside XWalk2?	N/A
	Road Slope (%)	3.5	N/A	Clear Space?	N/A
	Road X Slope (%)	4.3	N/A	Clear Space to XWalk (in)	N/A
N/A	Any Obstructions?	N/A	N/A	Storm Grate/Utility Hazard?	N/A
	Obstruction Type			Storm Grate/Utility Type	
		N/A			N/A
			Yes	Surface Condition? (G/P)	Good

Remove & Replace Curb Ramp With Two New Directional Ramps or Equivalent.
