Access Compliance Report

Public Rights-of-Way

(Curb Ramps)

Intersection ID: 11501	Main Street: FOXFORD_PL	Cross Street: SHAMROCK_DR	Location: NW
ADA ID: DDC1051315DF	Ramp Type: PerpDiag	Initial Pass/Fail: Fail	Overall Compliance: No
Codes/Mitigation Info/Possible Solution		Field Measurements/Component Compliance	
Severity Score: 8.75

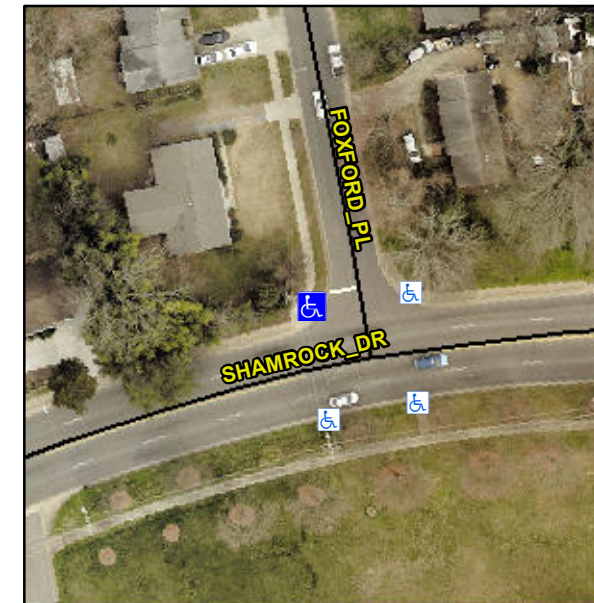
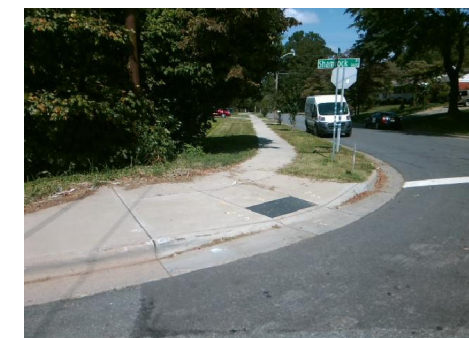
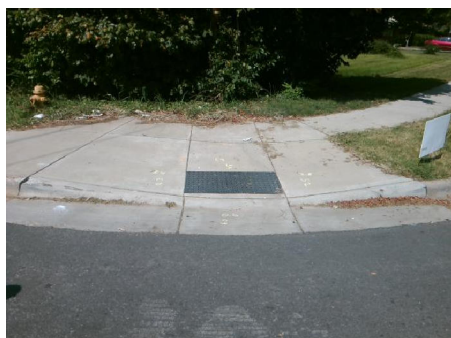
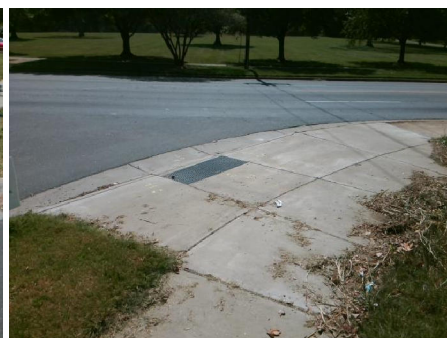
Compliance	Description	Data	Compliance	Description	Data
N/A	Ramp Length (in)	74.0	Yes	Ramp Slope (%)	5.4
No	Ramp Width (in)	47.0	Yes	Ramp XSlope (%)	1.4
N/A	Flare Type LT	N/A	N/A	Flare Type RT	N/A
N/A	Flare Slope LT (%)	N/A	N/A	Flare Slope RT (%)	N/A
N/A	Flare Traversable LT?	N/A	N/A	Flare Traversable RT?	N/A
N/A	Landing Length (in)	N/A	N/A	DWS Provided?	N/A
N/A	Landing Width (in)	N/A	N/A	DWS Contrast?	N/A
N/A	Landing Slope (%)	N/A	N/A	DWS Length (in)	N/A
N/A	Landing X Slope (%)	N/A	N/A	DWS Full Width?	N/A
N/A	Landing Curb? (Y/N)	N/A	N/A	DWS Offset (in)	N/A
N/A	Shared Landing?	N/A			
N/A	Gutter Ponding?	N/A	N/A	Gutter Slope (%)	N/A
N/A	Gutter Lip Ht (in)	N/A	N/A	Gutter X Slope (%)	N/A
N/A	Painted X Walk1?	No	N/A	Painted X Walk2?	No
	X Walk 1 Direction	To S		X Walk 2 Direction	To E
N/A	X Walk 1 Width (in)	N/A	N/A	X Walk 2 Width (in)	N/A
	X Walk 1 Slope (%)	2.0		X Walk 2 Slope (%)	5.2
	X Walk 1 X Slope (%)	3.4		X Walk 2 X Slope (%)	2.8

N/A	Ramp inside XWalk1?	N/A	N/A	Ramp inside XWalk2?	N/A
	Road Slope (%)	0.6	N/A	Clear Space?	N/A
	Road X Slope (%)	6.0	N/A	Clear Space to XWalk (in)	N/A
N/A	Any Obstructions?	N/A	N/A	Storm Grate/Utility Hazard?	N/A
	Obstruction Type			Storm Grate/Utility Type	
		N/A			N/A
			Yes	Surface Condition? (G/P)	Good

Possible Solutions:

Remove & Replace Curb Ramp With Two New Directional Ramps or Equivalent.
