Access Compliance Report

Public Rights-of-Way

(Curb Ramps)

Intersection ID: 12150	Main Street: W MARTIN LUTHER KING JR BLVD	Cross Street: S GRAHAM ST	Location: E
ADA ID: DDC54A367496	Ramp Type: Perp	Initial Pass/Fail: Fail	Overall Compliance: No
Severity Score: 21.25			
Codes/Mitigation Info/Possible Solution		Field Measurements/Component Compliance

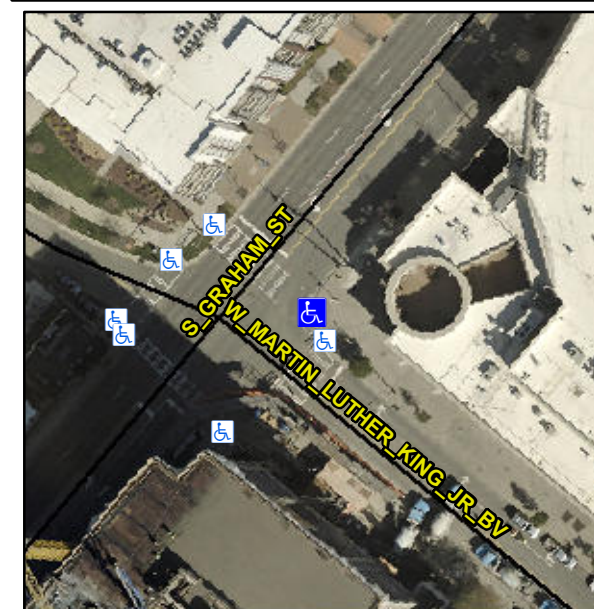
Compliance	Description	Data	Compliance	Description	Data
N/A	Ramp Length (in)	78.0	Yes	Ramp Slope (%)	7.6
No	Ramp Width (in)	47.5	No	Ramp XSlope (%)	5.9
N/A	Flare Type LT	N/A	N/A	Flare Type RT	N/A
N/A	Flare Slope LT (%)	N/A	N/A	Flare Slope RT (%)	N/A
N/A	Flare Traversable LT?	N/A	N/A	Flare Traversable RT?	N/A
N/A	Landing Length (in)	N/A	N/A	DWS Provided?	N/A
N/A	Landing Width (in)	N/A	N/A	DWS Contrast?	N/A
N/A	Landing Slope (%)	N/A	N/A	DWS Length (in)	N/A
N/A	Landing X Slope (%)	N/A	N/A	DWS Full Width?	N/A
N/A	Landing Curb? (Y/N)	N/A	N/A	DWS Offset (in)	N/A
N/A	Shared Landing?	N/A			
N/A	Gutter Ponding?	N/A	N/A	Gutter Slope (%)	N/A
N/A	Gutter Lip Ht (in)	N/A	N/A	Gutter X Slope (%)	N/A
N/A	Painted X Walk1?	Yes	N/A	Painted X Walk2?	N/A
	X Walk 1 Direction	To NW		X Walk 2 Direction	N/A
N/A	X Walk 1 Width (in)	170.0	N/A	X Walk 2 Width (in)	N/A
	X Walk 1 Slope (%)	0.5		X Walk 2 Slope (%)	N/A
	X Walk 1 X Slope (%)	3.8		X Walk 2 X Slope (%)	N/A

N/A	Ramp inside XWalk1?	Yes	N/A	Ramp inside XWalk2?	N/A
	Road Slope (%)	N/A	N/A	Clear Space?	N/A
	Road X Slope (%)	N/A	N/A	Clear Space to XWalk (in)	N/A
N/A	Any Obstructions?	N/A	N/A	Storm Grate/Utility Hazard?	N/A
	Obstruction Type			Storm Grate/Utility Type	
		N/A			N/A
		Yes		Surface Condition? (G/P)	Good

Possible Solutions:

Remove & Replace Entire Ramp.

R304.5.1, R304.5.3
