## Access Compliance Report Public Rights-of-Way (Curb Ramps)

Intersection ID: 21461 Main Street: FOREST\_POINT\_BV Cross Street: W\_ARROWOOD\_RD Location: N

ADA ID: DDC85C335B4F Ramp Type: PerpDiag Initial Pass/Fail: Fail Overall Compliance: No Severity Score: 46.25

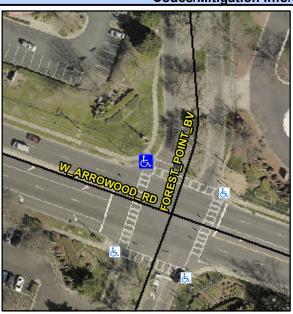
Not Found, R304.5.1, R304.2.2, R304.5.3

Compliance Description Data Compliance Description Data No N/A Ramp Length (in) 123.0 Ramp Slope (%) 9.2 No Ramp XSlope (%) No Ramp Width (in) 39.0 11.0 N/A N/A Flare Type LT N/A Flare Type RT N/A N/A N/A Flare Slope RT (%) Flare Slope LT (%) N/A N/A N/A Flare Traversable LT? N/A N/A Flare Traversable RT? N/A N/A N/A N/A **DWS Provided?** N/A Landing Length (in) N/A Landing Width (in) N/A N/A **DWS Contrast?** N/A N/A N/A Landing Slope (%) N/A DWS Length (in) N/A N/A Landing X Slope (%) N/A N/A DWS Full Width? N/A N/A Landing Curb? (Y/N) N/A N/A DWS Offset (in) N/A N/A N/A Shared Landing? N/A Gutter Ponding? N/A N/A Gutter Slope (%) N/A N/A Gutter Lip Ht (in) N/A N/A Gutter X Slope (%) N/A N/A Painted X Walk1? Yes N/A Painted X Walk2? Yes X Walk 1 Direction To SW X Walk 2 Direction To SE N/A 111.0 N/A 85.0 X Walk 1 Width (in) X Walk 2 Width (in) X Walk 1 Slope (%) 3.5 X Walk 2 Slope (%) 4.4 X Walk 1 X Slope (%) 1.7 X Walk 2 X Slope (%) 2.6 N/A N/A Ramp inside XWalk2? Ramp inside XWalk1? Yes No Road Slope (%) 5.4 N/A Clear Space? N/A N/A Road X Slope (%) Clear Space to XWalk (in) N/A 0.1 N/A N/A Any Obstructions? N/A Storm Grate/Utility Hazard? N/A **Obstruction Type** Storm Grate/Utility Type N/A N/A Yes Surface Condition? (G/P) Good

Remove & Replace Curb Ramp With Two New Directional Ramps or Equivalent. Restripe Crosswalk.
