## **Access Compliance Report Public Rights-of-Way** (Curb Ramps)

Intersection ID: 54294 Main Street: PROVIDENCE LN WEST **Cross Street: ASHTON RIDGE LN** Location: SE ADA ID: DDCA7CF4F494 Ramp Type: Directional1 Initial Pass/Fail: Fail **Overall Compliance: No Severity Score:** 12.5

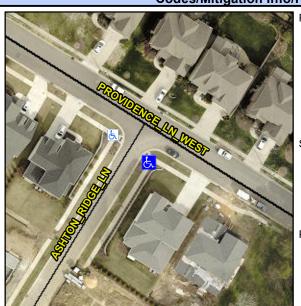
Compliance Description		Data	Compliance Description		Data
N/A	Ramp Length (in)	81.0	N/A	Grade Break?	N/A
Yes	Ramp Width (in)	60.0	N/A	Grade Break Slope (%)	0.0
No	Ramp Slope (%)	10.7	N/A	Grade Break XSlope (%)	0.0
Yes	Ramp XSlope (%)	1.8			
N/A	Flare Type LT	N/A	N/A	Flare Type RT	N/A
N/A	Flare Slope LT (%)	N/A	N/A	Flare Slope RT (%)	0.0
N/A	Flare Traversable LT?	N/A	N/A	Flare Traversable RT?	N/A
N/A	Landing Length (in)	0.0	N/A	DWS Provided?	N/A
N/A	Landing Width (in)	0.0	N/A	DWS Contrast?	N/A
N/A	Landing Slope (%)	0.0	N/A	DWS Length (in)	N/A
N/A	Landing X Slope (%)	0.0	N/A	DWS Full Width?	N/A
N/A	Landing Curb? (Y/N)	N/A	N/A	DWS Offset LT (in)	N/A
N/A	Shared Landing?	N/A	N/A	DWS Offset RT (in)	N/A
N/A	Gutter Ponding?	0.0	N/A	Gutter Slope (%)	N/A
N/A	Gutter Lip Ht (in)	0.0	N/A	Gutter X Slope (%)	N/A
N/A	Painted X Walk1?	No		Road Slope (%)	0.7
	X Walk 1 Direction	To NW		Road X Slope (%)	3.0
	X Walk 1 Width (in)	N/A		Clear Space?	N/A

X Walk 1 Slope (%)	0.7	N/A	Clear Space to XWalk (in)	N/A
	X Walk 1 X Slope (%)	3.0	N/A	Storm Grate/Utility Hazard?	N/A
N/A	Ramp inside XWalk1?	N/A		Storm Grate/Utility Type	
N/A	Any Obstructions?	N/A			N/A
	Obstruction Type		Yes	Surface Condition? (G/P)	Good
		N/A	N/A	Curb Slope (%)	5.7

**ASHTON RIDGE LN** Street 1 Name Stop Condition-Street 1 StopSign Street 2 Name N/A Stop Condition-Street 2 N/A Possible Solutions: Remove & Replace Entire Ramp. Surveyor Notes: N/A PROW/ADA: R304.2.2
