Access Compliance Report

Public Rights-of-Way

(Curb Ramps)

Intersection ID: 51491	Main Street: N_TRYON_ST	Cross Street: INSTITUTE_CR	Location:	N
ADA ID: DDCFA1D62211	Ramp Type: Perp	Initial Pass/Fail: Fail	Overall Compliance: No	Severity Score: 10
Codes/Mitigation Info/Possible Solution		Field Measurements/Component Compliance

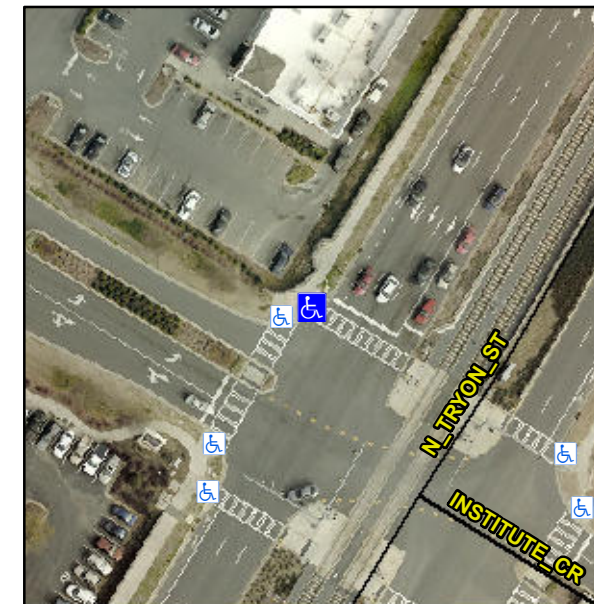
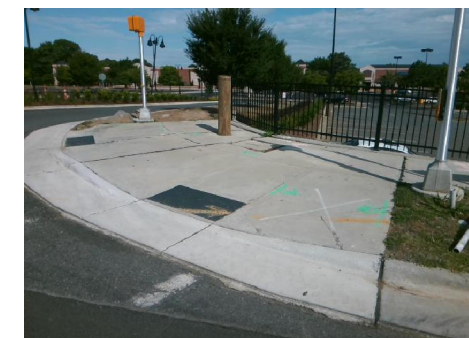
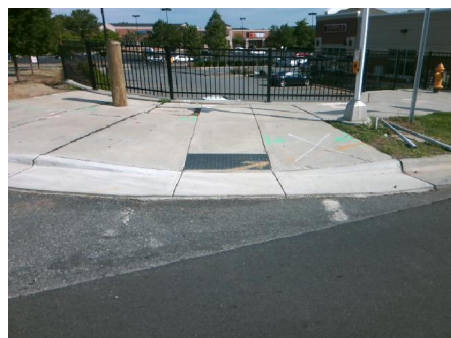
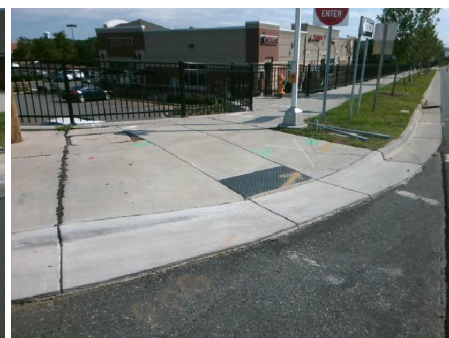
R304.5.1, R304.5.3

Compliance	Description	Data	Compliance	Description	Data
N/A	Ramp Length (in)	95.0	Yes	Ramp Slope (%)	6.8
No	Ramp Width (in)	47.0	No	Ramp XSlope (%)	3.5
N/A	Flare Type LT	N/A	N/A	Flare Type RT	N/A
N/A	Flare Slope LT (%)	N/A	N/A	Flare Slope RT (%)	N/A
N/A	Flare Traversable LT?	N/A	N/A	Flare Traversable RT?	N/A
N/A	Landing Length (in)	N/A	N/A	DWS Provided?	N/A
N/A	Landing Width (in)	N/A	N/A	DWS Contrast?	N/A
N/A	Landing Slope (%)	N/A	N/A	DWS Length (in)	N/A
N/A	Landing X Slope (%)	N/A	N/A	DWS Full Width?	N/A
N/A	Landing Curb? (Y/N)	N/A	N/A	DWS Offset (in)	N/A
N/A	Shared Landing?	N/A			
N/A	Gutter Ponding?	N/A	N/A	Gutter Slope (%)	N/A
N/A	Gutter Lip Ht (in)	2.0	N/A	Gutter X Slope (%)	N/A
N/A	Painted X Walk1?	No	N/A	Painted X Walk2?	N/A
	X Walk 1 Direction	To SE		X Walk 2 Direction	N/A
N/A	X Walk 1 Width (in)	N/A	N/A	X Walk 2 Width (in)	N/A
	X Walk 1 Slope (%)	1.4		X Walk 2 Slope (%)	N/A
	X Walk 1 X Slope (%)	3.3		X Walk 2 X Slope (%)	N/A

N/A	Ramp inside XWalk1?	N/A	N/A	Ramp inside XWalk2?	N/A
	Road Slope (%)	N/A	N/A	Clear Space?	N/A
	Road X Slope (%)	N/A	N/A	Clear Space to XWalk (in)	N/A
N/A	Any Obstructions?	N/A	N/A	Storm Grate/Utility Hazard?	N/A
	Obstruction Type			Storm Grate/Utility Type	
		N/A			N/A
			Yes	Surface Condition? (G/P)	Good

Remove & Replace Entire Ramp.

Total Cost: \$ 1850.00
