# Access Compliance Report

## Public Rights-of-Way

### (Curb Ramps)

Intersection ID: 2907	Main Street: EVERGREEN_HOLLOW_DR	Cross Street: GOLDENFIELD_DR	Location: W
ADA ID: DDD52F287E44	Ramp Type: PerpDiag	Initial Pass/Fail: Fail	Overall Compliance: No
Codes/Mitigation Info/Possible Solution		Field Measurements/Component Compliance

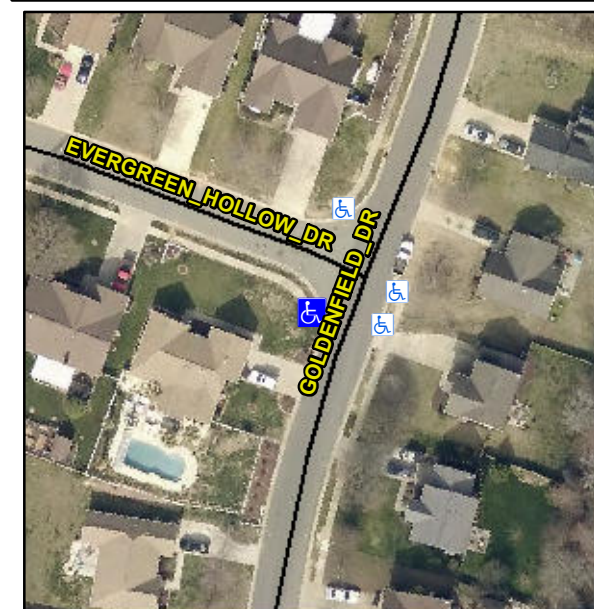
**Not Found, R304.2.2, R304.5.3**

Compliance	Description	Data	Compliance	Description	Data
N/A	Ramp Length (in)	47.0	No	Ramp Slope (%)	9.2
Yes	Ramp Width (in)	48.0	No	Ramp XSlope (%)	3.0
N/A	Flare Type LT	N/A	N/A	Flare Type RT	N/A
N/A	Flare Slope LT (%)	N/A	N/A	Flare Slope RT (%)	N/A
N/A	Flare Traversable LT?	N/A	N/A	Flare Traversable RT?	N/A
N/A	Landing Length (in)	N/A	N/A	DWS Provided?	N/A
N/A	Landing Width (in)	N/A	N/A	DWS Contrast?	N/A
N/A	Landing Slope (%)	N/A	N/A	DWS Length (in)	N/A
N/A	Landing X Slope (%)	N/A	N/A	DWS Full Width?	N/A
N/A	Landing Curb? (Y/N)	N/A	N/A	DWS Offset (in)	N/A
N/A	Shared Landing?	N/A			
N/A	Gutter Ponding?	N/A	N/A	Gutter Slope (%)	N/A
N/A	Gutter Lip Ht (in)	N/A	N/A	Gutter X Slope (%)	N/A
N/A	Painted X Walk1?	No	N/A	Painted X Walk2?	No
	X Walk 1 Direction	To SE		X Walk 2 Direction	To NE
N/A	X Walk 1 Width (in)	N/A	N/A	X Walk 2 Width (in)	N/A
	X Walk 1 Slope (%)	7.1		X Walk 2 Slope (%)	5.1
	X Walk 1 X Slope (%)	4.1		X Walk 2 X Slope (%)	4.0

N/A	Ramp inside XWalk1?	N/A	N/A	Ramp inside XWalk2?	N/A
	Road Slope (%)	5.2	N/A	Clear Space?	N/A
	Road X Slope (%)	5.4	N/A	Clear Space to XWalk (in)	N/A
N/A	Any Obstructions?	N/A	N/A	Storm Grate/Utility Hazard?	N/A
	Obstruction Type			Storm Grate/Utility Type	
		N/A			N/A
			Yes	Surface Condition? (G/P)	Good

**Remove & Replace Curb Ramp With Two New Directional Ramps or Equivalent.**
