Intersection ID: 30003	Main Street: CHEPSTOW_CT	Cross Street: KEMPSFORD_DR	Location:	E
ADA ID: DDDDB428154ED	Ramp Type: PerpDiag	Initial Pass/Fail: Fail	Overall Compliance: No	Severity Score: 13.75

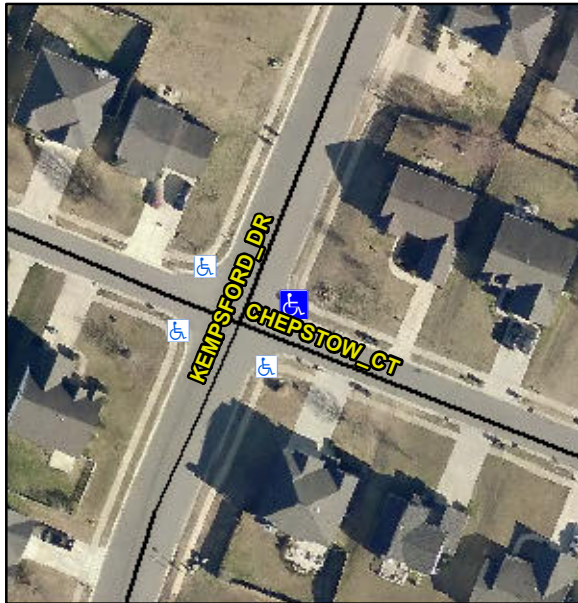
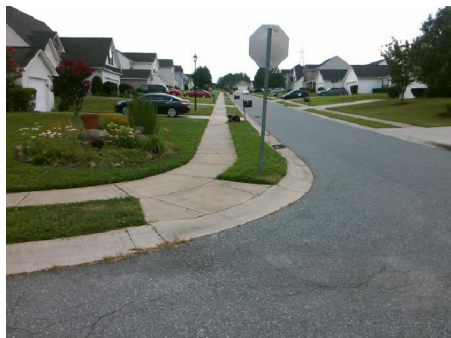
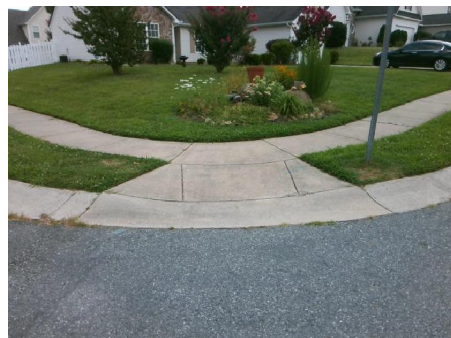
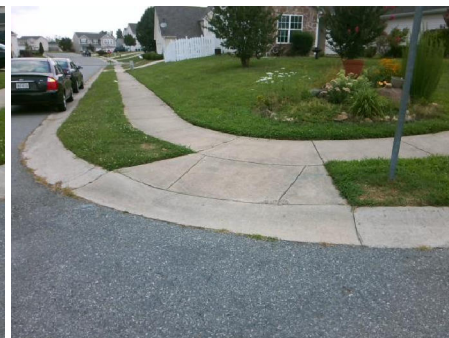
**Not Found, R304.2.2, R304.5.3**

Compliance	Description	Data	Compliance	Description	Data
N/A	Ramp Length (in)	45.0	No	Ramp Slope (%)	9.8
Yes	Ramp Width (in)	51.0	No	Ramp XSlope (%)	3.3
N/A	Flare Type LT	N/A	N/A	Flare Type RT	N/A
N/A	Flare Slope LT (%)	N/A	N/A	Flare Slope RT (%)	N/A
N/A	Flare Traversable LT?	N/A	N/A	Flare Traversable RT?	N/A
N/A	Landing Length (in)	N/A	N/A	DWS Provided?	N/A
N/A	Landing Width (in)	N/A	N/A	DWS Contrast?	N/A
N/A	Landing Slope (%)	N/A	N/A	DWS Length (in)	N/A
N/A	Landing X Slope (%)	N/A	N/A	DWS Full Width?	N/A
N/A	Landing Curb? (Y/N)	N/A	N/A	DWS Offset (in)	N/A
N/A	Shared Landing?	N/A			
N/A	Gutter Ponding?	N/A	N/A	Gutter Slope (%)	N/A
N/A	Gutter Lip Ht (in)	N/A	N/A	Gutter X Slope (%)	N/A
N/A	Painted X Walk1?	No	N/A	Painted X Walk2?	No
	X Walk 1 Direction	To NW		X Walk 2 Direction	To SW
N/A	X Walk 1 Width (in)	N/A	N/A	X Walk 2 Width (in)	N/A
	X Walk 1 Slope (%)	2.1		X Walk 2 Slope (%)	2.5
	X Walk 1 X Slope (%)	0.9		X Walk 2 X Slope (%)	3.2

N/A	Ramp inside XWalk1?	N/A	N/A	Ramp inside XWalk2?	N/A
	Road Slope (%)	1.2	N/A	Clear Space?	N/A
	Road X Slope (%)	1.3	N/A	Clear Space to XWalk (in)	N/A
N/A	Any Obstructions?	N/A	N/A	Storm Grate/Utility Hazard?	N/A
	Obstruction Type			Storm Grate/Utility Type	
		N/A			N/A
			Yes	Surface Condition? (G/P)	Good

**Remove & Replace Curb Ramp With Two New Directional Ramps or Equivalent.**
