# Access Compliance Report

## Public Rights-of-Way

### (Curb Ramps)

| Intersection ID: 31624 | Main Street: BRADFORD_DR | Cross Street: THOMASBORO_DR | Location: NW |

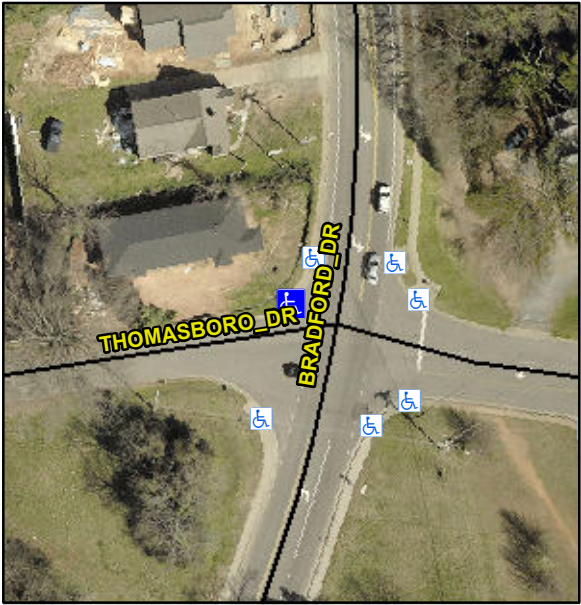
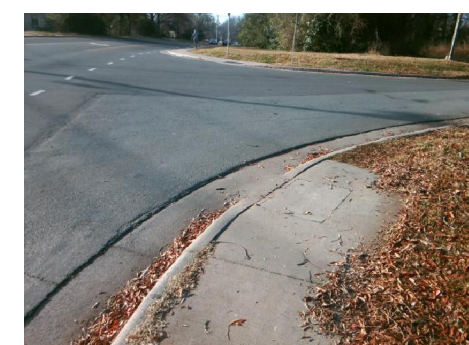
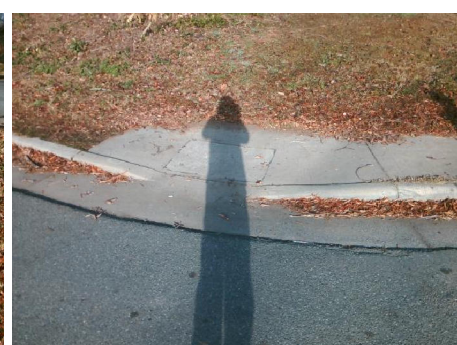
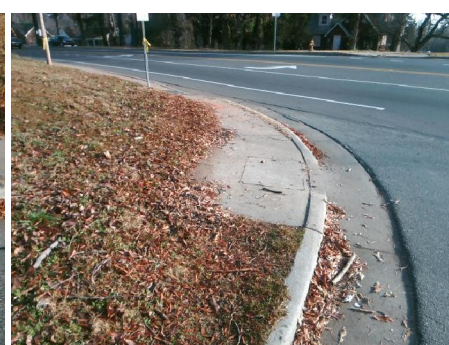
| ADA ID: DDD9C5F09BA | Ramp Type: Perp | Initial Pass/Fail: Fail | Overall Compliance: No |

| Codes/Mitigation Info/Possible Solution | | | Field Measurements/Component Compliance | | |
|---|---|---|---|---|---|
| | <b>Remove &amp; Replace Entire Ramp.</b> | | <b>No</b> | Ramp Length (in) | <b>59.0</b> |
| | | | <b>No</b> | Ramp Width (in) | <b>40.0</b> |
| <p>Surveyor Notes:</p> <p><b>N/A</b></p> <p>PROW/ADA:</p> <p><b>R304.5.1, R304.2.2, R304.5.3</b></p> | | | <b>N/A</b> | Flare Type RT | <b>N/A</b> |
