# Access Compliance Report

## Public Rights-of-Way

### (Curb Ramps)

Intersection ID: 13975	Main Street: E_8TH_ST	Cross Street: PECAN_AV	Location: S
ADA ID: DDDD91F7AB11	Ramp Type: PerpDiag	Initial Pass/Fail: Fail	Overall Compliance: No
			Severity Score: 13.75

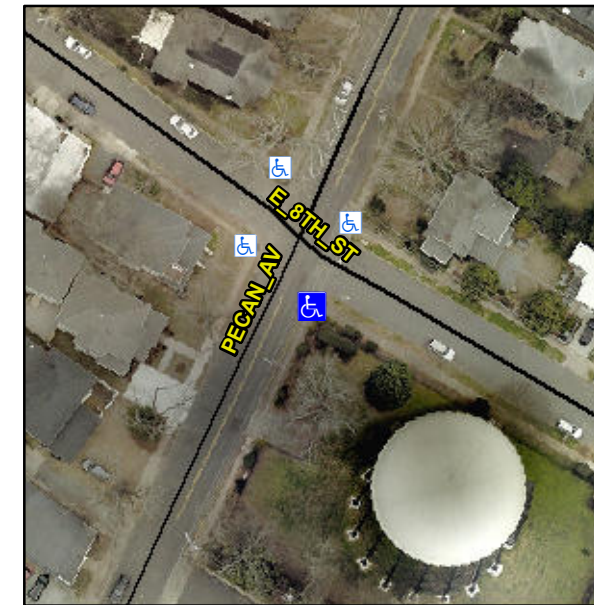
**Not Found, R304.2.2, R304.5.3**

Compliance	Description	Data	Compliance	Description	Data
N/A	Ramp Length (in)	79.0	No	Ramp Slope (%)	11.1
Yes	Ramp Width (in)	48.0	No	Ramp XSlope (%)	3.7
N/A	Flare Type LT	N/A	N/A	Flare Type RT	N/A
N/A	Flare Slope LT (%)	N/A	N/A	Flare Slope RT (%)	N/A
N/A	Flare Traversable LT?	N/A	N/A	Flare Traversable RT?	N/A
N/A	Landing Length (in)	N/A	N/A	DWS Provided?	N/A
N/A	Landing Width (in)	N/A	N/A	DWS Contrast?	N/A
N/A	Landing Slope (%)	N/A	N/A	DWS Length (in)	N/A
N/A	Landing X Slope (%)	N/A	N/A	DWS Full Width?	N/A
N/A	Landing Curb? (Y/N)	N/A	N/A	DWS Offset (in)	N/A
N/A	Shared Landing?	N/A			
N/A	Gutter Ponding?	N/A	N/A	Gutter Slope (%)	N/A
N/A	Gutter Lip Ht (in)	N/A	N/A	Gutter X Slope (%)	N/A
N/A	Painted X Walk1?	No	N/A	Painted X Walk2?	No
	X Walk 1 Direction	To NE		X Walk 2 Direction	To NW
N/A	X Walk 1 Width (in)	N/A	N/A	X Walk 2 Width (in)	N/A
	X Walk 1 Slope (%)	0.1		X Walk 2 Slope (%)	4.3
	X Walk 1 X Slope (%)	2.3		X Walk 2 X Slope (%)	0.8

N/A	Ramp inside XWalk1?	N/A	N/A	Ramp inside XWalk2?	N/A
	Road Slope (%)	1.9	N/A	Clear Space?	N/A
	Road X Slope (%)	4.1	N/A	Clear Space to XWalk (in)	N/A
N/A	Any Obstructions?	N/A	N/A	Storm Grate/Utility Hazard?	N/A
	Obstruction Type			Storm Grate/Utility Type	
		N/A			N/A
			Yes	Surface Condition? (G/P)	Good

**Remove & Replace Curb Ramp With Two New Directional Ramps or Equivalent.**
