Intersection ID: N/A	Main Street: ARDREY_KELL_RD	Cross Street: WAVERLY_WALK_AV	Location:	SE
ADA ID: DE0E1B285027	Ramp Type: Directional1	Initial Pass/Fail: Fail	Overall Compliance: No	Severity Score: 12.5

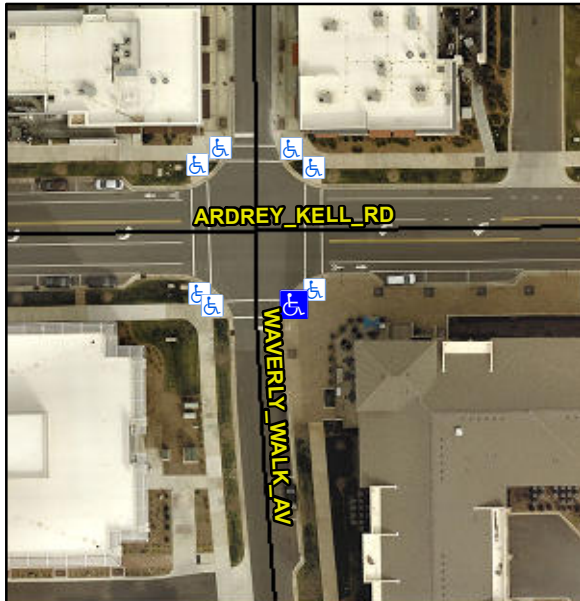
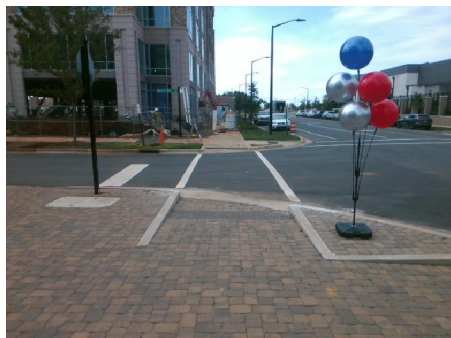
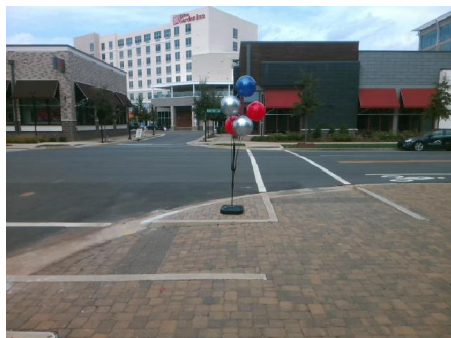
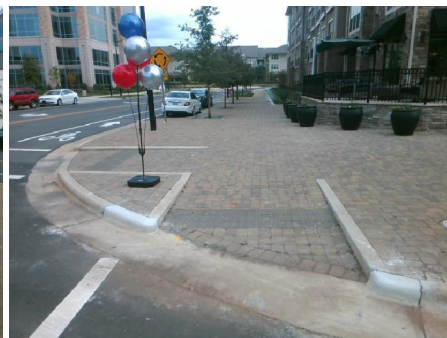
Possible Solutions:			Compliance	Description	Data	Compliance	Description	Data
	Remove & Replace Entire Ramp.			N/A	Ramp Length (in)	96.0	N/A	Grade Break?	N/A
				Yes	Ramp Width (in)	89.0	N/A	Grade Break Slope (%)	0.0
				Yes	Ramp Slope (%)	3.8	N/A	Grade Break XSlope (%)	0.0
				No	Ramp XSlope (%)	5.9			
				N/A	Flare Type LT	N/A	N/A	Flare Type RT	N/A
				N/A	Flare Slope LT (%)	N/A	N/A	Flare Slope RT (%)	0.0
				N/A	Flare Traversable LT?	N/A	N/A	Flare Traversable RT?	N/A
				N/A	Landing Length (in)	0.0	N/A	DWS Provided?	N/A
				N/A	Landing Width (in)	0.0	N/A	DWS Contrast?	N/A
Surveyor Notes:			N/A	N/A	Landing Slope (%)	0.0	N/A	DWS Length (in)	N/A
				N/A	Landing X Slope (%)	0.0	N/A	DWS Full Width?	N/A
PROW/ADA:			R304.5.3	N/A	Landing Curb? (Y/N)	N/A	N/A	DWS Offset LT (in)	N/A
				N/A	Shared Landing?	N/A	N/A	DWS Offset RT (in)	N/A

N/A	Gutter Ponding?	0.0	N/A	Gutter Slope (%)	N/A
				N/A	Gutter Lip Ht (in)	0.0	N/A	Gutter X Slope (%)	N/A
				N/A	Painted X Walk1?	Yes		Road Slope (%)	0.5
					X Walk 1 Direction	To W		Road X Slope (%)	1.3
					X Walk 1 Width (in)	113.0		Clear Space?	N/A
					X Walk 1 Slope (%)	0.5	N/A	Clear Space to XWalk (in)	N/A
					X Walk 1 X Slope (%)	1.3	N/A	Storm Grate/Utility Hazard?	N/A
				N/A	Ramp inside XWalk1?	Yes		Storm Grate/Utility Type	
				N/A	Any Obstructions?	N/A			N/A
					Obstruction Type		Yes	Surface Condition? (G/P)	Good
						N/A	N/A	Curb Slope (%)	1.5
Total Cost:			\$ 1600.00						
Street 1 Name				WAVERLY WALK AV					
Stop Condition-Street 1				StopSign					
Street 2 Name				N/A					
Stop Condition-Street 2				N/A
