Access Compliance Report

Public Rights-of-Way

(Curb Ramps)

Intersection ID: 9982	Main Street: E_36TH_ST	Cross Street: N_DAVIDSON_ST	Location: W
ADA ID: DE10176AC3AE	Ramp Type: PerpDiag	Initial Pass/Fail: Fail	Overall Compliance: No
		Severity Score: 12.5

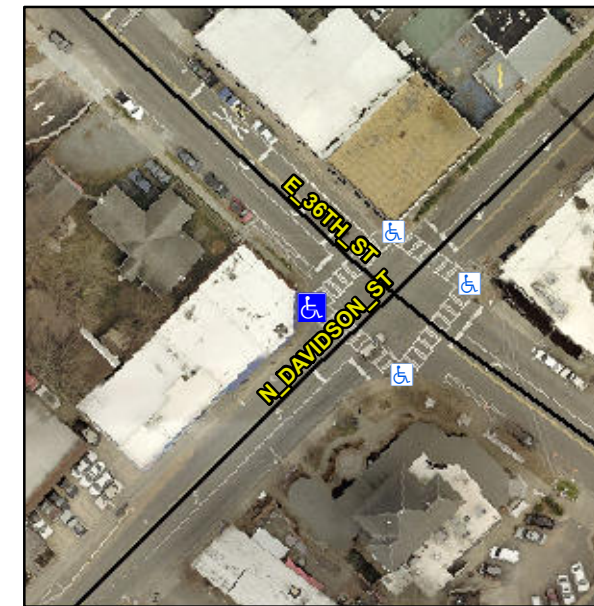
Compliance	Description	Data	Compliance	Description	Data
N/A	Ramp Length (in)	56.0	No	Ramp Slope (%)	11.1
Yes	Ramp Width (in)	48.0	Yes	Ramp XSlope (%)	1.0
N/A	Flare Type LT	N/A	N/A	Flare Type RT	N/A
N/A	Flare Slope LT (%)	N/A	N/A	Flare Slope RT (%)	N/A
N/A	Flare Traversable LT?	N/A	N/A	Flare Traversable RT?	N/A
N/A	Landing Length (in)	N/A	N/A	DWS Provided?	N/A
N/A	Landing Width (in)	N/A	N/A	DWS Contrast?	N/A
N/A	Landing Slope (%)	N/A	N/A	DWS Length (in)	N/A
N/A	Landing X Slope (%)	N/A	N/A	DWS Full Width?	N/A
N/A	Landing Curb? (Y/N)	N/A	N/A	DWS Offset (in)	N/A
N/A	Shared Landing?	N/A			
N/A	Gutter Ponding?	N/A	N/A	Gutter Slope (%)	N/A
N/A	Gutter Lip Ht (in)	1.0	N/A	Gutter X Slope (%)	N/A
N/A	Painted X Walk1?	Yes	N/A	Painted X Walk2?	Yes
	X Walk 1 Direction	To SE		X Walk 2 Direction	To NE
N/A	X Walk 1 Width (in)	112.0	N/A	X Walk 2 Width (in)	108.0
	X Walk 1 Slope (%)	5.8		X Walk 2 Slope (%)	1.6
	X Walk 1 X Slope (%)	1.5		X Walk 2 X Slope (%)	2.1

N/A	Ramp inside XWalk1?	Yes	N/A	Ramp inside XWalk2?	Yes
	Road Slope (%)	1.1	N/A	Clear Space?	N/A
	Road X Slope (%)	1.2	N/A	Clear Space to XWalk (in)	N/A
N/A	Any Obstructions?	N/A	N/A	Storm Grate/Utility Hazard?	N/A
	Obstruction Type			Storm Grate/Utility Type	
		N/A			N/A
		Yes		Surface Condition? (G/P)	Good

Remove & Replace Curb Ramp With Two New Directional Ramps or Equivalent.

R304.2.2
