Access Compliance Report

Public Rights-of-Way

(Curb Ramps)

Intersection ID: 10038344	Main Street: SOUTH_BV	Cross Street: N/A	Location: E
ADA ID: DE16DB5E4E2B	Ramp Type: Perp	Initial Pass/Fail: Fail	Overall Compliance: No
Severity Score: 8.75			
Codes/Mitigation Info/Possible Solution		Field Measurements/Component Compliance

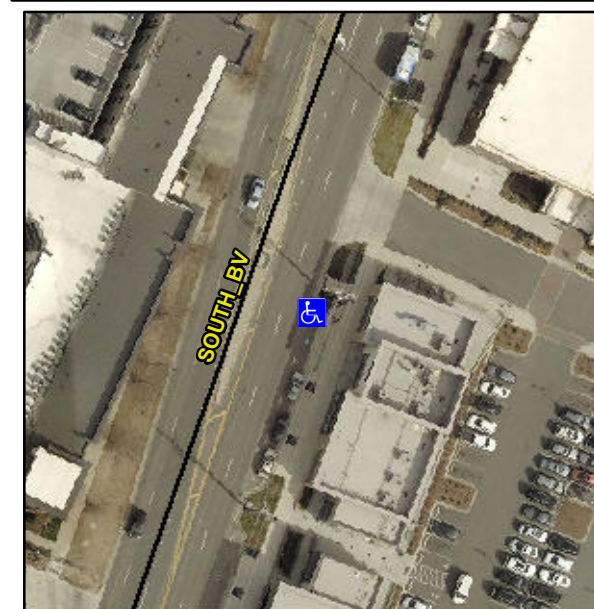
Not Found, R304.5.1

Compliance	Description	Data	Compliance	Description	Data
N/A	Ramp Length (in)	62.5	Yes	Ramp Slope (%)	7.2
No	Ramp Width (in)	46.0	Yes	Ramp XSlope (%)	1.5
N/A	Flare Type LT	N/A	N/A	Flare Type RT	N/A
N/A	Flare Slope LT (%)	N/A	N/A	Flare Slope RT (%)	N/A
N/A	Flare Traversable LT?	N/A	N/A	Flare Traversable RT?	N/A
N/A	Landing Length (in)	N/A	N/A	DWS Provided?	N/A
N/A	Landing Width (in)	N/A	N/A	DWS Contrast?	N/A
N/A	Landing Slope (%)	N/A	N/A	DWS Length (in)	N/A
N/A	Landing X Slope (%)	N/A	N/A	DWS Full Width?	N/A
N/A	Landing Curb? (Y/N)	N/A	N/A	DWS Offset (in)	N/A
N/A	Shared Landing?	N/A			
N/A	Gutter Ponding?	N/A	N/A	Gutter Slope (%)	N/A
N/A	Gutter Lip Ht (in)	N/A	N/A	Gutter X Slope (%)	N/A
N/A	Painted X Walk1?	No	N/A	Painted X Walk2?	N/A
	X Walk 1 Direction	To NW		X Walk 2 Direction	N/A
N/A	X Walk 1 Width (in)	N/A	N/A	X Walk 2 Width (in)	N/A
	X Walk 1 Slope (%)	0.1		X Walk 2 Slope (%)	N/A
	X Walk 1 X Slope (%)	1.3		X Walk 2 X Slope (%)	N/A

Remove & Replace Entire Ramp.

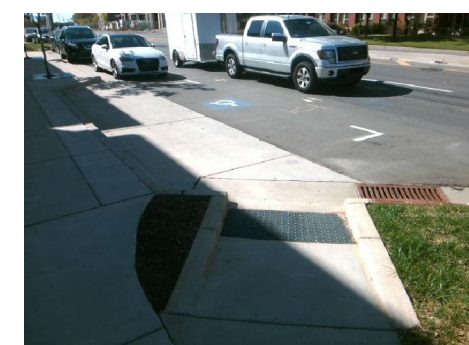
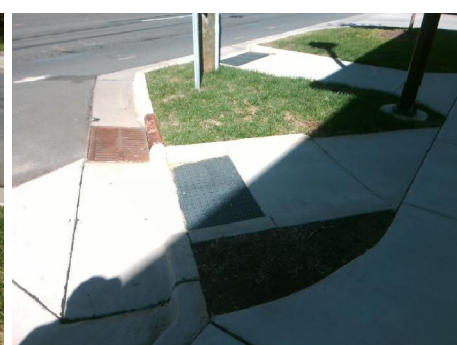
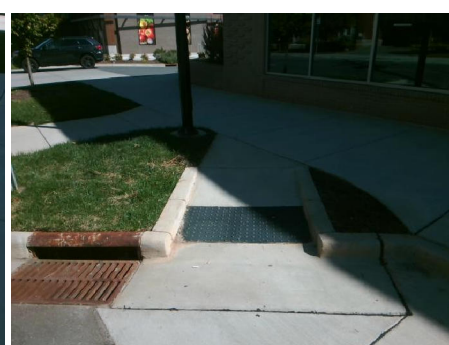
N/A	Ramp inside XWalk1?	N/A	N/A	Ramp inside XWalk2?	N/A
	Road Slope (%)	N/A	N/A	Clear Space?	N/A
	Road X Slope (%)	N/A	N/A	Clear Space to XWalk (in)	N/A
N/A	Any Obstructions?	N/A	N/A	Storm Grate/Utility Hazard?	N/A
	Obstruction Type			Storm Grate/Utility Type	
		N/A			N/A
			Yes	Surface Condition? (G/P)	Good
