Access Compliance Report

Public Rights-of-Way

(Curb Ramps)

Intersection ID: 13908	Main Street: BAY_ST	Cross Street: ST_JULIEN_ST	Location: W
ADA ID: DE27508DA1F7	Ramp Type: PerpDiag	Initial Pass/Fail: Fail	Overall Compliance: No
Severity Score: 25			
Codes/Mitigation Info/Possible Solution		Field Measurements/Component Compliance

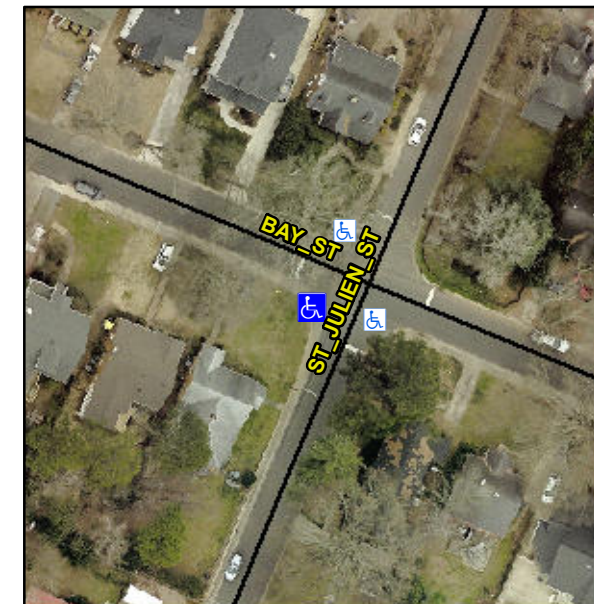
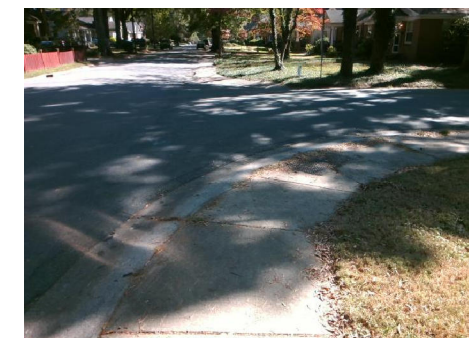
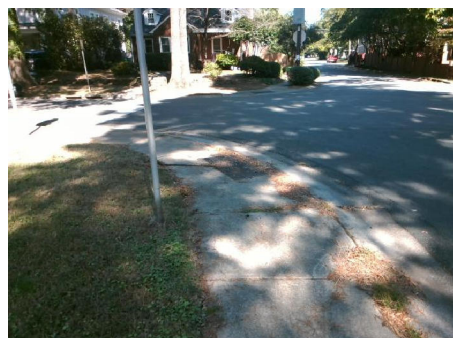
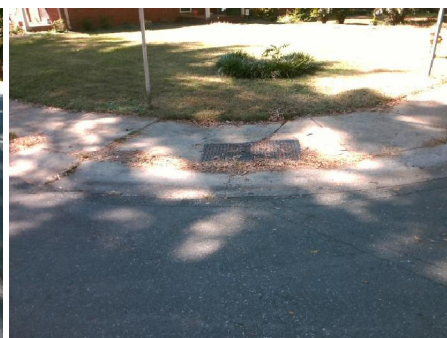
Not Found, R304.5.3

Compliance	Description	Data	Compliance	Description	Data
N/A	Ramp Length (in)	60.0	Yes	Ramp Slope (%)	5.4
Yes	Ramp Width (in)	127.0	No	Ramp XSlope (%)	7.2
N/A	Flare Type LT	N/A	N/A	Flare Type RT	N/A
N/A	Flare Slope LT (%)	N/A	N/A	Flare Slope RT (%)	N/A
N/A	Flare Traversable LT?	N/A	N/A	Flare Traversable RT?	N/A
N/A	Landing Length (in)	N/A	N/A	DWS Provided?	N/A
N/A	Landing Width (in)	N/A	N/A	DWS Contrast?	N/A
N/A	Landing Slope (%)	N/A	N/A	DWS Length (in)	N/A
N/A	Landing X Slope (%)	N/A	N/A	DWS Full Width?	N/A
N/A	Landing Curb? (Y/N)	N/A	N/A	DWS Offset (in)	N/A
N/A	Shared Landing?	N/A			
N/A	Gutter Ponding?	N/A	N/A	Gutter Slope (%)	N/A
N/A	Gutter Lip Ht (in)	0.5	N/A	Gutter X Slope (%)	N/A
N/A	Painted X Walk1?	No	N/A	Painted X Walk2?	No
	X Walk 1 Direction	To SE		X Walk 2 Direction	To NE
N/A	X Walk 1 Width (in)	N/A	N/A	X Walk 2 Width (in)	N/A
	X Walk 1 Slope (%)	4.4		X Walk 2 Slope (%)	5.5
	X Walk 1 X Slope (%)	4.0		X Walk 2 X Slope (%)	1.5

N/A	Ramp inside XWalk1?	N/A	N/A	Ramp inside XWalk2?	N/A
	Road Slope (%)	1.8	N/A	Clear Space?	N/A
	Road X Slope (%)	5.0	N/A	Clear Space to XWalk (in)	N/A
N/A	Any Obstructions?	N/A	N/A	Storm Grate/Utility Hazard?	N/A
	Obstruction Type			Storm Grate/Utility Type	
		N/A			N/A
		Yes		Surface Condition? (G/P)	Good

Remove & Replace Curb Ramp With Two New Directional Ramps or Equivalent.
