# Access Compliance Report

## Public Rights-of-Way

### (Curb Ramps)

| Intersection ID: 10016095 | Main Street: PENCE_RD | Cross Street: N/A | Location: S |

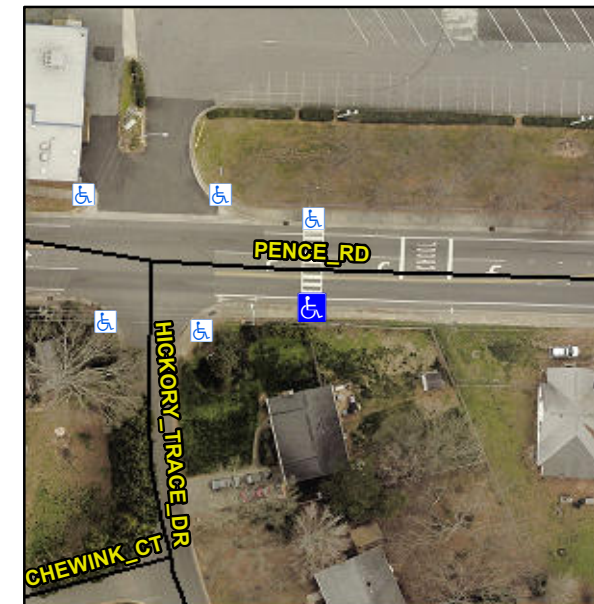
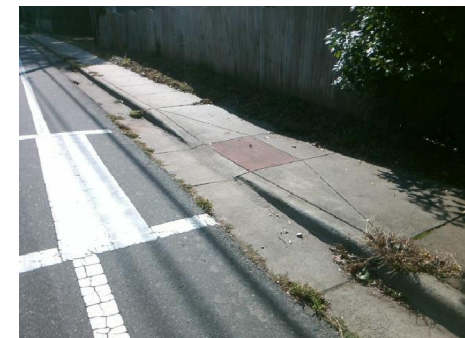
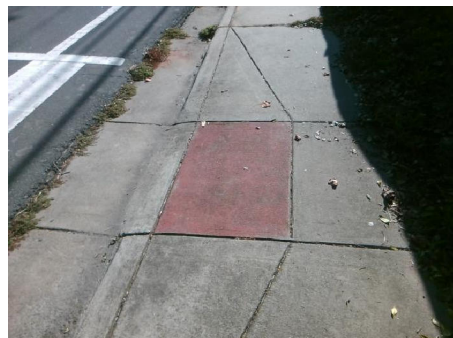
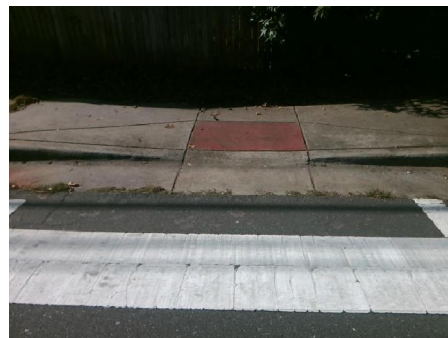
| ADA ID: DE289459570F | Ramp Type: BlendTrans1 | Initial Pass/Fail: Fail | Overall Compliance: No |
| | | Severity Score: 8.75 | |

**Not Found, R304.5.1**

| Compliance | Description | Data | Compliance | Description | Data |
|---|---|---|---|---|---|
| No | Ramp Width (in) | 47.0 | Yes | BlendTrans XSlope (%) | 1.8 |
| | | | No | Curb Slope (%) | 18.7 |

**Remove & Replace Curb Ramp With Two New Directional Ramps or Equivalent.**

Total Cost: \$ 3200.00
