# Access Compliance Report

## Public Rights-of-Way

### (Curb Ramps)

Intersection ID: 10006563	Main Street: SHADE_VALLEY_RD	Cross Street: OAKHURST_COMMONS_DR	Location: SW
ADA ID: DE2AB3577DB5	Ramp Type: Perp	Initial Pass/Fail: Fail	Overall Compliance: No
Severity Score: 25			
Codes/Mitigation Info/Possible Solution		Field Measurements/Component Compliance

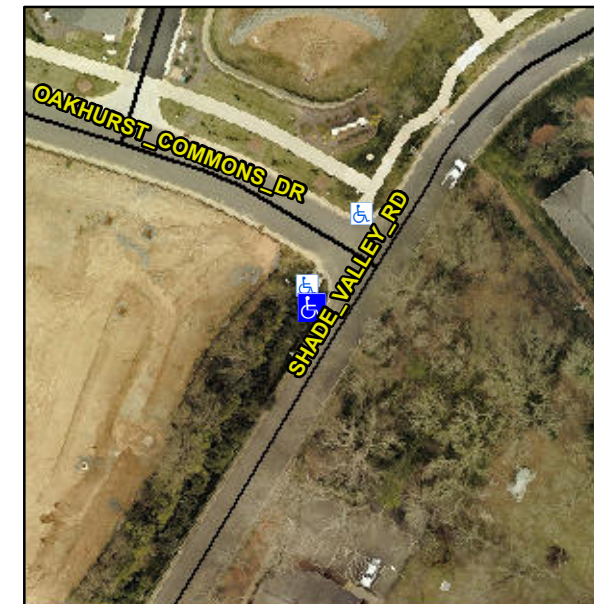
Compliance	Description	Data	Compliance	Description	Data
N/A	Ramp Length (in)	71.0	No	Ramp Slope (%)	10.0
Yes	Ramp Width (in)	90.0	No	Ramp XSlope (%)	5.7
N/A	Flare Type LT	N/A	N/A	Flare Type RT	N/A
N/A	Flare Slope LT (%)	N/A	N/A	Flare Slope RT (%)	N/A
N/A	Flare Traversable LT?	N/A	N/A	Flare Traversable RT?	N/A
N/A	Landing Length (in)	N/A	N/A	DWS Provided?	N/A
N/A	Landing Width (in)	N/A	N/A	DWS Contrast?	N/A
N/A	Landing Slope (%)	N/A	N/A	DWS Length (in)	N/A
N/A	Landing X Slope (%)	N/A	N/A	DWS Full Width?	N/A
N/A	Landing Curb? (Y/N)	N/A	N/A	DWS Offset (in)	N/A
N/A	Shared Landing?	N/A			
N/A	Gutter Ponding?	N/A	N/A	Gutter Slope (%)	N/A
N/A	Gutter Lip Ht (in)	N/A	N/A	Gutter X Slope (%)	N/A
N/A	Painted X Walk1?	No	N/A	Painted X Walk2?	N/A
	X Walk 1 Direction	To SE		X Walk 2 Direction	N/A
N/A	X Walk 1 Width (in)	N/A	N/A	X Walk 2 Width (in)	N/A
	X Walk 1 Slope (%)	2.8		X Walk 2 Slope (%)	N/A
	X Walk 1 X Slope (%)	334		X Walk 2 X Slope (%)	N/A

N/A	Ramp inside XWalk1?	N/A	N/A	Ramp inside XWalk2?	N/A
	Road Slope (%)	N/A	N/A	Clear Space?	N/A
	Road X Slope (%)	N/A	N/A	Clear Space to XWalk (in)	N/A
N/A	Any Obstructions?	N/A	N/A	Storm Grate/Utility Hazard?	N/A
	Obstruction Type			Storm Grate/Utility Type	
		N/A			N/A
			Yes	Surface Condition? (G/P)	Good

Possible Solutions:

**Remove & Replace Entire Ramp.**

**R304.2.2, R304.5.3**

Total Cost: \$ 1850.00
