Access Compliance Report Public Rights-of-Way (Curb Ramps)

Intersection ID: 14589 Main Street: CHICAGO_AV Cross Street: TOOMEY_AV Location: E

ADA ID: DE30FD3DA5FE Ramp Type: PerpDiag Initial Pass/Fail: Fail Overall Compliance: No Severity Score: 8.75

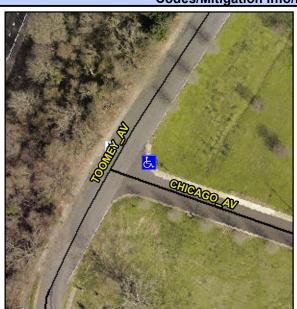
PROW/ADA:
Not Found, R304.5.1

Compliance Description		Data	Compliance Description		Data
N/A	Ramp Length (in)	52.0	Yes	Ramp Slope (%)	5.2
No	Ramp Width (in)	40.0	Yes	Ramp XSlope (%)	0.9
N/A	Flare Type LT	N/A	N/A	Flare Type RT	N/A
N/A	Flare Slope LT (%)	N/A	N/A	Flare Slope RT (%)	N/A
N/A	Flare Traversable LT?	N/A	N/A	Flare Traversable RT?	N/A
N/A	Landing Length (in)	N/A	N/A	DWS Provided?	N/A
N/A	Landing Width (in)	N/A	N/A	DWS Contrast?	N/A
N/A	Landing Slope (%)	N/A	N/A	DWS Length (in)	N/A
N/A	Landing X Slope (%)	N/A	N/A	DWS Full Width?	N/A
N/A	Landing Curb? (Y/N)	N/A	N/A	DWS Offset (in)	N/A
N/A	Shared Landing?	N/A			
N/A	Gutter Ponding?	N/A	N/A	Gutter Slope (%)	N/A
N/A	Gutter Lip Ht (in)	N/A	N/A	Gutter X Slope (%)	N/A
N/A	Painted X Walk1?	No	N/A	Painted X Walk2?	No
	X Walk 1 Direction	To NW		X Walk 2 Direction	To SW
N/A	X Walk 1 Width (in)	N/A	N/A	X Walk 2 Width (in)	N/A
	X Walk 1 Slope (%)	0.4		X Walk 2 Slope (%)	4.2
	X Walk 1 X Slope (%)	4.8		X Walk 2 X Slope (%)	0.6

TOOMEY AV None CHICAGO AV StopSign Possible Solutions:

Remove & Replace Curb Ramp With
Two New Directional Ramps or
Equivalent.
