Access Compliance Report

Public Rights-of-Way

(Curb Ramps)

Intersection ID: 19236	Main Street: MCDOWELL_FARMS_DR	Cross Street: MOUNTING_ROCK_RD	Location: NW
ADA ID: DE313294567F	Ramp Type: Directional1	Initial Pass/Fail: Pass	Overall Compliance: No
			Severity Score: 10.25

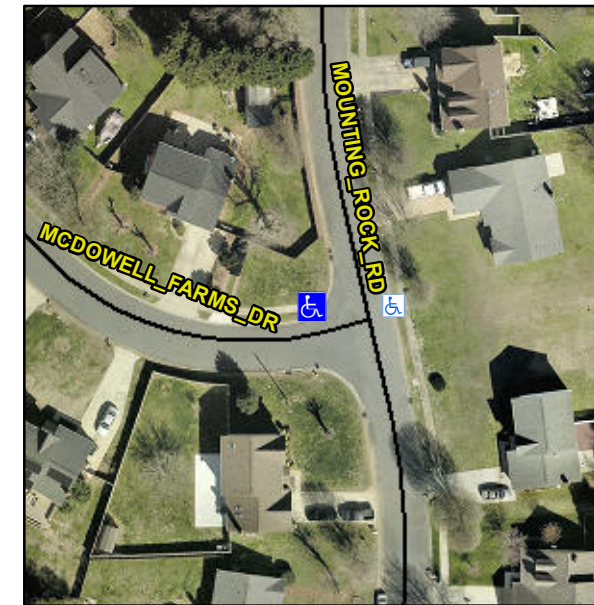
Compliance	Description	Data	Compliance	Description	Data
N/A	Ramp Length (in)	95.0	No	Grade Break?	No
Yes	Ramp Width (in)	50.0	N/A	Grade Break Slope (%)	N/A
Yes	Ramp Slope (%)	7.7	N/A	Grade Break XSlope (%)	N/A
No	Ramp XSlope (%)	4.2			
N/A	Flare Type LT	N/A	N/A	Flare Type RT	N/A
N/A	Flare Slope LT (%)	N/A	N/A	Flare Slope RT (%)	N/A
N/A	Flare Traversable LT?	N/A	N/A	Flare Traversable RT?	N/A
Yes	Landing Length (in)	48.0	No	DWS Provided?	No
Yes	Landing Width (in)	48.0	N/A	DWS Contrast?	No
No	Landing Slope (%)	3.9	N/A	DWS Length (in)	N/A
No	Landing X Slope (%)	2.7	N/A	DWS Full Width?	No
N/A	Landing Curb? (Y/N)	N/A	N/A	DWS Offset LT (in)	N/A
N/A	Shared Landing?	No	N/A	DWS Offset RT (in)	N/A
Yes	Gutter Ponding?	No	Yes	Gutter Slope (%)	0.3
Yes	Gutter Lip Ht (in)	0.0	Yes	Gutter X Slope (%)	0.1
N/A	Painted X Walk1?	No		Road Slope (%)	2.0
	X Walk 1 Direction	To E		Road X Slope (%)	0.4
	X Walk 1 Width (in)	N/A		Clear Space?	Yes

X Walk 1 Slope (%)	2.0	N/A	Clear Space to XWalk (in)	N/A
	X Walk 1 X Slope (%)	0.4	Yes	Storm Grate/Utility Hazard?	No
N/A	Ramp inside XWalk1?	N/A		Storm Grate/Utility Type	
Yes	Any Obstructions?	No			N/A
	Obstruction Type		Yes	Surface Condition? (G/P)	Good
			N/A	Curb Slope (%)	8.8

Possible Solutions:

Remove & Replace Entire Ramp.
