Access Compliance Report Public Rights-of-Way (Curb Ramps)

Intersection ID: 53405 Main Street: LUTHER_ST Cross Street: MORGAN_PARK_DR Location: S

ADA ID: DE34D48E8531 Ramp Type: ParaDiag Initial Pass/Fail: Fail Overall Compliance: No Severity Score: 33.75

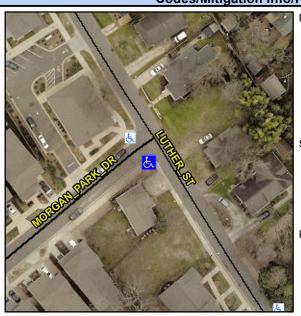
NoRamp Width LT (in)37.0YesRamp Width RT (in)7NoRamp Slope LT (%)13.0YesRamp Slope RT (%)YesRamp XSlope LT (%)0.2YesRamp XSlope RT (%)N/ALanding Length (in)N/AN/ADWS Provided?IN/ALanding Width (in)N/AN/ADWS Contrast?IN/ALanding Slope (%)N/AN/ADWS Length (in)I	ata
NoRamp Slope LT (%)13.0YesRamp Slope RT (%)YesRamp XSlope LT (%)0.2YesRamp XSlope RT (%)N/ALanding Length (in)N/AN/ADWS Provided?IN/ALanding Width (in)N/AN/ADWS Contrast?IN/ALanding Slope (%)N/AN/ADWS Length (in)I	4.0
Yes Ramp XSlope LT (%) N/A Landing Length (in) N/A Landing Width (in) N/A Landing Slope (%) N/A DWS Contrast? N/A DWS Length (in) N/A DWS Length (in)	1.0
N/ALanding Length (in)N/AN/ADWS Provided?N/ALanding Width (in)N/AN/ADWS Contrast?N/ALanding Slope (%)N/AN/ADWS Length (in)	6.9
N/A Landing Width (in) N/A DWS Contrast? N/A Landing Slope (%) N/A DWS Length (in)	1.6
N/A Landing Slope (%) N/A N/A DWS Length (in)	N/A
	N/A
N/A Landing V Clara (0/) N/A N/A D/A/C Full M/d4450	N/A

N/A Landing X Slope (%) N/A N/A DWS Full Width?	N/A
N/A Landing Curb? (Y/N) N/A N/A DWS Offset (in)	N/A
N/A Shared Landing? N/A	
N/A Gutter Ponding? N/A N/A Gutter Slope (%)	N/A
N/A Gutter Lip Ht (in) N/A N/A Gutter X Slope (%)	N/A
N/A Painted X Walk1? No N/A Painted X Walk2?	No
X Walk 1 Direction To NE X Walk 2 Direction To I	٧W
N/A X Walk 1 Width (in) N/A N/A X Walk 2 Width (in)	N/A
X Walk 1 Slope (%) 0.3 X Walk 2 Slope (%)	3.4
X Walk 1 X Slope (%) 1.0 X Walk 2 X Slope (%)	2.9
N/A Ramp inside XWalk1? N/A N/A Ramp inside XWalk2?	N/A
Road Slope (%) 3.7 N/A Clear Space?	N/A
Road X Slope (%) 2.1 N/A Clear Space to XWalk (in)	N/A
N/A Any Obstructions? N/A N/A Storm Grate/Utility Hazard?	N/A
Obstruction Type Storm Grate/Utility Type	
N/A	N/A
Yes Surface Condition? (G/P) Go	od
N/A Curb Slope (%)	5.2

LUTHER ST None MORGAN PARK DR StopSign Possible Solutions:

Remove & Replace Curb Ramp With
Two New Directional Ramps or
Equivalent.

R304.5.1, R304.3.2
