Access Compliance Report

Public Rights-of-Way

(Curb Ramps)

Intersection ID: 18436	Main Street: E_INDEPENDENCE_BV	Cross Street: SHARON_FOREST_DR	Location: NE
ADA ID: DE39475D4269	Ramp Type: PerpDiag	Initial Pass/Fail: Fail	Overall Compliance: No
Severity Score: 22.5			
Codes/Mitigation Info/Possible Solution		Field Measurements/Component Compliance

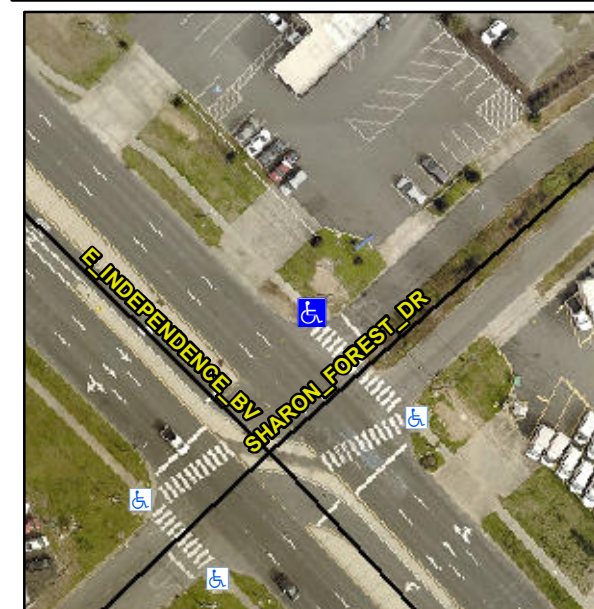
Not Found, R304.5.1, R304.2.2, R304.5.3

Compliance	Description	Data	Compliance	Description	Data
N/A	Ramp Length (in)	66.0	No	Ramp Slope (%)	11.8
No	Ramp Width (in)	45.0	No	Ramp XSlope (%)	2.7
N/A	Flare Type LT	N/A	N/A	Flare Type RT	N/A
N/A	Flare Slope LT (%)	N/A	N/A	Flare Slope RT (%)	N/A
N/A	Flare Traversable LT?	N/A	N/A	Flare Traversable RT?	N/A
N/A	Landing Length (in)	N/A	N/A	DWS Provided?	N/A
N/A	Landing Width (in)	N/A	N/A	DWS Contrast?	N/A
N/A	Landing Slope (%)	N/A	N/A	DWS Length (in)	N/A
N/A	Landing X Slope (%)	N/A	N/A	DWS Full Width?	N/A
N/A	Landing Curb? (Y/N)	N/A	N/A	DWS Offset (in)	N/A
N/A	Shared Landing?	N/A			
N/A	Gutter Ponding?	N/A	N/A	Gutter Slope (%)	N/A
N/A	Gutter Lip Ht (in)	N/A	N/A	Gutter X Slope (%)	N/A
N/A	Painted X Walk1?	No	N/A	Painted X Walk2?	Yes
	X Walk 1 Direction	To SW		X Walk 2 Direction	To SE
N/A	X Walk 1 Width (in)	N/A	N/A	X Walk 2 Width (in)	120.0
	X Walk 1 Slope (%)	4.1		X Walk 2 Slope (%)	1.4
	X Walk 1 X Slope (%)	0.4		X Walk 2 X Slope (%)	3.1

N/A	Ramp inside XWalk1?	N/A	N/A	Ramp inside XWalk2?	Yes
	Road Slope (%)	2.4	N/A	Clear Space?	N/A
	Road X Slope (%)	2.5	N/A	Clear Space to XWalk (in)	N/A
N/A	Any Obstructions?	N/A	N/A	Storm Grate/Utility Hazard?	N/A
	Obstruction Type			Storm Grate/Utility Type	
		N/A			N/A
		Yes		Surface Condition? (G/P)	Good

Remove & Replace Curb Ramp With Two New Directional Ramps or Equivalent.
