Intersection ID: 27325	Main Street: TILLEY_MORRIS_RD	Cross Street: N/A	Location:	N
ADA ID: DE3BA7D4DBB2	Ramp Type: Perp	Initial Pass/Fail: Fail	Overall Compliance: No	Severity Score: 1.25

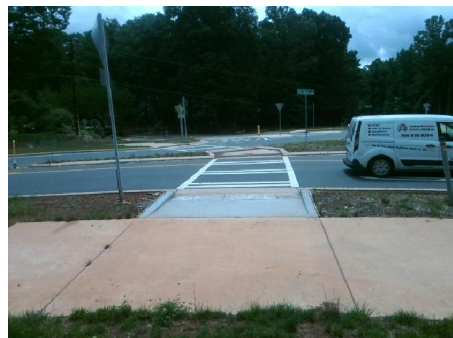
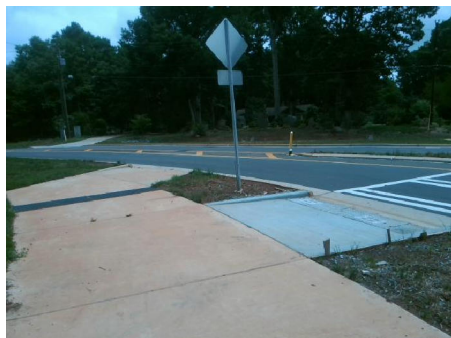
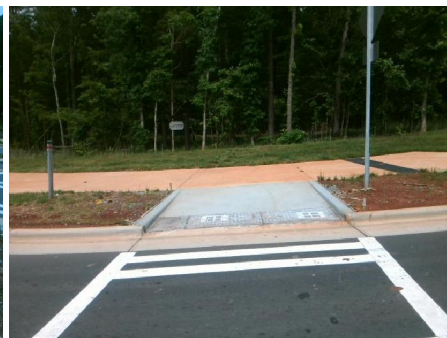
## Not Found, R304.5.3

Compliance	Description	Data	Compliance	Description	Data
N/A	Ramp Length (in)	96.0	Yes	Ramp Slope (%)	7.0
Yes	Ramp Width (in)	108.0	No	Ramp XSlope (%)	4.2
N/A	Flare Type LT	N/A	N/A	Flare Type RT	N/A
N/A	Flare Slope LT (%)	N/A	N/A	Flare Slope RT (%)	N/A
N/A	Flare Traversable LT?	N/A	N/A	Flare Traversable RT?	N/A
N/A	Landing Length (in)	N/A	N/A	DWS Provided?	N/A
N/A	Landing Width (in)	N/A	N/A	DWS Contrast?	N/A
N/A	Landing Slope (%)	N/A	N/A	DWS Length (in)	N/A
N/A	Landing X Slope (%)	N/A	N/A	DWS Full Width?	N/A
N/A	Landing Curb? (Y/N)	N/A	N/A	DWS Offset (in)	N/A
N/A	Shared Landing?	N/A			
N/A	Gutter Ponding?	N/A	N/A	Gutter Slope (%)	N/A
N/A	Gutter Lip Ht (in)	N/A	N/A	Gutter X Slope (%)	N/A
N/A	Painted X Walk1?	Yes	N/A	Painted X Walk2?	N/A
	X Walk 1 Direction	To E		X Walk 2 Direction	N/A
N/A	X Walk 1 Width (in)	112.0	N/A	X Walk 2 Width (in)	N/A
	X Walk 1 Slope (%)	0.9		X Walk 2 Slope (%)	N/A
	X Walk 1 X Slope (%)	3.1		X Walk 2 X Slope (%)	N/A

N/A	Ramp inside XWalk1?	Yes	N/A	Ramp inside XWalk2?	N/A
	Road Slope (%)	N/A	N/A	Clear Space?	N/A
	Road X Slope (%)	N/A	N/A	Clear Space to XWalk (in)	N/A
N/A	Any Obstructions?	N/A	N/A	Storm Grate/Utility Hazard?	N/A
	Obstruction Type			Storm Grate/Utility Type	
		N/A			N/A
			Yes	Surface Condition? (G/P)	Good

### Remove & Replace Entire Ramp.

**Total Cost: \$ 1850.00**
