Access Compliance Report

Public Rights-of-Way

(Curb Ramps)

Intersection ID: 10014838	Main Street: THE_PLAZA	Cross Street: N/A	Location: SE
ADA ID: DE3DA14DBB41	Ramp Type: PerpDiag	Initial Pass/Fail: Fail	Overall Compliance: No
		Severity Score: 12.5	
Codes/Mitigation Info/Possible Solution		Field Measurements/Component Compliance

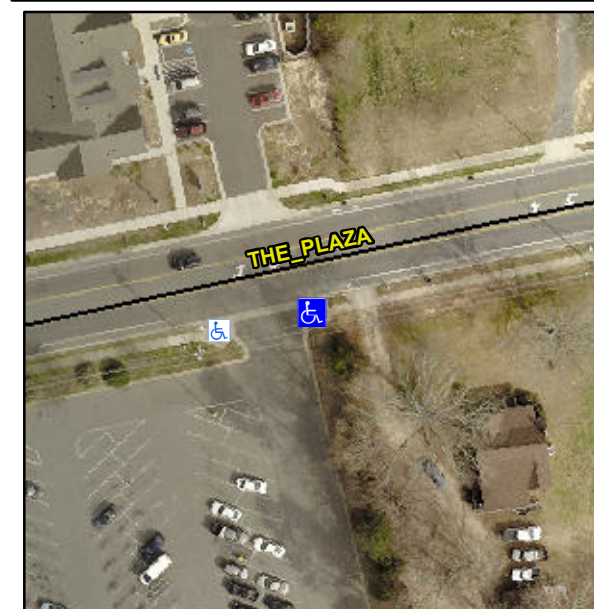
Not Found, R304.2.2

Compliance	Description	Data	Compliance	Description	Data
N/A	Ramp Length (in)	47.0	No	Ramp Slope (%)	8.9
Yes	Ramp Width (in)	48.0	Yes	Ramp XSlope (%)	1.9
N/A	Flare Type LT	N/A	N/A	Flare Type RT	N/A
N/A	Flare Slope LT (%)	N/A	N/A	Flare Slope RT (%)	N/A
N/A	Flare Traversable LT?	N/A	N/A	Flare Traversable RT?	N/A
N/A	Landing Length (in)	N/A	N/A	DWS Provided?	N/A
N/A	Landing Width (in)	N/A	N/A	DWS Contrast?	N/A
N/A	Landing Slope (%)	N/A	N/A	DWS Length (in)	N/A
N/A	Landing X Slope (%)	N/A	N/A	DWS Full Width?	N/A
N/A	Landing Curb? (Y/N)	N/A	N/A	DWS Offset (in)	N/A
N/A	Shared Landing?	N/A			
N/A	Gutter Ponding?	N/A	N/A	Gutter Slope (%)	N/A
N/A	Gutter Lip Ht (in)	N/A	N/A	Gutter X Slope (%)	N/A
N/A	Painted X Walk1?	No	N/A	Painted X Walk2?	No
	X Walk 1 Direction	To N		X Walk 2 Direction	To W
N/A	X Walk 1 Width (in)	N/A	N/A	X Walk 2 Width (in)	N/A
	X Walk 1 Slope (%)	1.1		X Walk 2 Slope (%)	0.5
	X Walk 1 X Slope (%)	1.5		X Walk 2 X Slope (%)	0.2

N/A	Ramp inside XWalk1?	N/A	N/A	Ramp inside XWalk2?	N/A
	Road Slope (%)	0.1	N/A	Clear Space?	N/A
	Road X Slope (%)	0.1	N/A	Clear Space to XWalk (in)	N/A
N/A	Any Obstructions?	N/A	N/A	Storm Grate/Utility Hazard?	N/A
	Obstruction Type			Storm Grate/Utility Type	
		N/A			N/A
			Yes	Surface Condition? (G/P)	Good

Remove & Replace Curb Ramp With Two New Directional Ramps or Equivalent.
