Access Compliance Report Public Rights-of-Way (Curb Ramps)

Intersection ID: 52818 Main Street: PROSPERITY_CHURCH_RD Cross Street: MCKAY_RD Location: SW

ADA ID: DE46777AFCF4 Ramp Type: Perp Initial Pass/Fail: Fail Overall Compliance: No Severity Score: 13.75

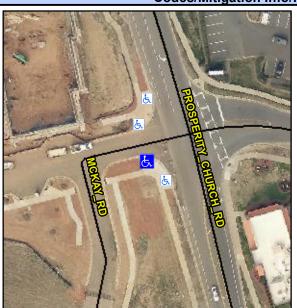
Field Measurements/Component Compliance						
Compliance Description			Data	Comp	oliance Description	Data
1	N/A	Ramp Length (in)	72.0	No	Ramp Slope (%)	10.2
١	⁄es	Ramp Width (in)	72.5	No	Ramp XSlope (%)	4.2
١	N/A	Flare Type LT	N/A	N/A	Flare Type RT	N/A
١	N/A	Flare Slope LT (%)	N/A	N/A	Flare Slope RT (%)	N/A
1	N/A	Flare Traversable LT?	N/A	N/A	Flare Traversable RT?	N/A
1	N/A	Landing Length (in)	N/A	N/A	DWS Provided?	N/A
1	N/A	Landing Width (in)	N/A	N/A	DWS Contrast?	N/A
1	N/A	Landing Slope (%)	N/A	N/A	DWS Length (in)	N/A
1	N/A	Landing X Slope (%)	N/A	N/A	DWS Full Width?	N/A
1	N/A	Landing Curb? (Y/N)	N/A	N/A	DWS Offset (in)	N/A
1	N/A	Shared Landing?	N/A			
1	N/A	Gutter Ponding?	N/A	N/A	Gutter Slope (%)	N/A
N	N/A	Gutter Lip Ht (in)	N/A	N/A	Gutter X Slope (%)	N/A
1	N/A	Painted X Walk1?	No	N/A	Painted X Walk2?	N/A
		X Walk 1 Direction	To N		X Walk 2 Direction	N/A
1	N/A	X Walk 1 Width (in)	N/A	N/A	X Walk 2 Width (in)	N/A

X Walk 1 Slope (%)	3.7		X Walk 2 Slope (%)	N/A
		X Walk 1 X Slope (%)	4.7		X Walk 2 X Slope (%)	N/A
1	N/A	Ramp inside XWalk1?	N/A	N/A	Ramp inside XWalk2?	N/A
		Road Slope (%)	N/A	N/A	Clear Space?	N/A
		Road X Slope (%)	N/A	N/A	Clear Space to XWalk (in)	N/A
ı	N/A	Any Obstructions?	N/A	N/A	Storm Grate/Utility Hazard?	N/A
		Obstruction Type			Storm Grate/Utility Type	
			N/A			N/A
				Yes	Surface Condition? (G/P)	Good

Remove & Replace Entire Ramp.

R304.2.2, R304.5.3
