Access Compliance Report

Public Rights-of-Way

(Curb Ramps)

Intersection ID: 10027733	Main Street: GRIFFITH_ST	Cross Street: N/A	Location: E
ADA ID: DE46EB440FFB	Ramp Type: Perp	Initial Pass/Fail: Fail	Overall Compliance: No
Severity Score: 8.75			
Codes/Mitigation Info/Possible Solution		Field Measurements/Component Compliance

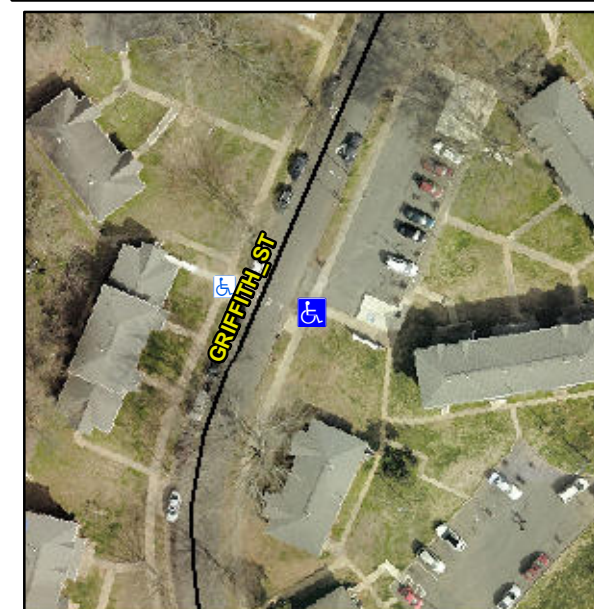
Compliance	Description	Data	Compliance	Description	Data
N/A	Ramp Length (in)	46.0	Yes	Ramp Slope (%)	6.6
No	Ramp Width (in)	47.5	Yes	Ramp XSlope (%)	0.6
N/A	Flare Type LT	N/A	N/A	Flare Type RT	N/A
N/A	Flare Slope LT (%)	N/A	N/A	Flare Slope RT (%)	N/A
N/A	Flare Traversable LT?	N/A	N/A	Flare Traversable RT?	N/A
N/A	Landing Length (in)	N/A	N/A	DWS Provided?	N/A
N/A	Landing Width (in)	N/A	N/A	DWS Contrast?	N/A
N/A	Landing Slope (%)	N/A	N/A	DWS Length (in)	N/A
N/A	Landing X Slope (%)	N/A	N/A	DWS Full Width?	N/A
N/A	Landing Curb? (Y/N)	N/A	N/A	DWS Offset (in)	N/A
N/A	Shared Landing?	N/A			
N/A	Gutter Ponding?	N/A	N/A	Gutter Slope (%)	N/A
N/A	Gutter Lip Ht (in)	N/A	N/A	Gutter X Slope (%)	N/A
N/A	Painted X Walk1?	Yes	N/A	Painted X Walk2?	N/A
	X Walk 1 Direction	To NW		X Walk 2 Direction	N/A
N/A	X Walk 1 Width (in)	41.0	N/A	X Walk 2 Width (in)	N/A
	X Walk 1 Slope (%)	2.3		X Walk 2 Slope (%)	N/A
	X Walk 1 X Slope (%)	0.6		X Walk 2 X Slope (%)	N/A

N/A	Ramp inside XWalk1?	Yes	N/A	Ramp inside XWalk2?	N/A
	Road Slope (%)	N/A	N/A	Clear Space?	N/A
	Road X Slope (%)	N/A	N/A	Clear Space to XWalk (in)	N/A
N/A	Any Obstructions?	N/A	N/A	Storm Grate/Utility Hazard?	N/A
	Obstruction Type			Storm Grate/Utility Type	
		N/A			N/A
			Yes	Surface Condition? (G/P)	Good

Possible Solutions:

Remove & Replace Entire Ramp.

Total Cost: \$ 1850.00
