# Access Compliance Report

## Public Rights-of-Way

### (Curb Ramps)

Intersection ID: 46344	Main Street: BENNETT_NEELY_LN	Cross Street: STREAM_BANK_DR	Location: NW
ADA ID: DE4EDF75B013	Ramp Type: PerpDiag	Initial Pass/Fail: Fail	Overall Compliance: No
Severity Score: 35			
Codes/Mitigation Info/Possible Solution		Field Measurements/Component Compliance

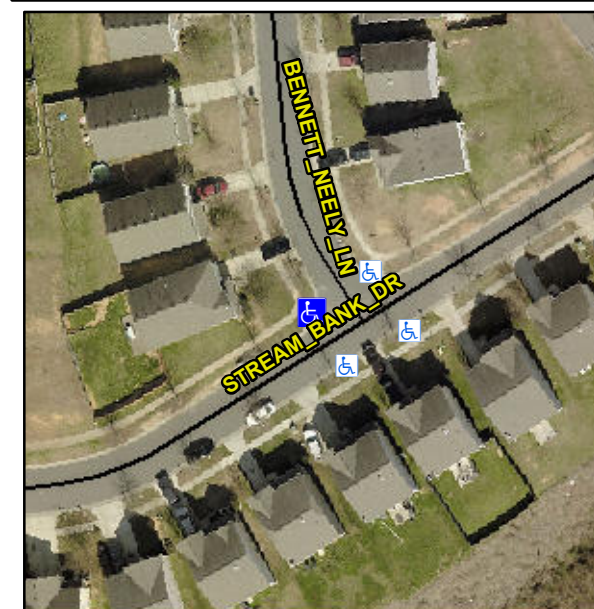
**Not Found, R304.5.1**

Compliance	Description	Data	Compliance	Description	Data
N/A	Ramp Length (in)	82.5	Yes	Ramp Slope (%)	7.7
No	Ramp Width (in)	28.5	Yes	Ramp XSlope (%)	1.6
N/A	Flare Type LT	N/A	N/A	Flare Type RT	N/A
N/A	Flare Slope LT (%)	N/A	N/A	Flare Slope RT (%)	N/A
N/A	Flare Traversable LT?	N/A	N/A	Flare Traversable RT?	N/A
N/A	Landing Length (in)	N/A	N/A	DWS Provided?	N/A
N/A	Landing Width (in)	N/A	N/A	DWS Contrast?	N/A
N/A	Landing Slope (%)	N/A	N/A	DWS Length (in)	N/A
N/A	Landing X Slope (%)	N/A	N/A	DWS Full Width?	N/A
N/A	Landing Curb? (Y/N)	N/A	N/A	DWS Offset (in)	N/A
N/A	Shared Landing?	N/A			
N/A	Gutter Ponding?	N/A	N/A	Gutter Slope (%)	N/A
N/A	Gutter Lip Ht (in)	0.5	N/A	Gutter X Slope (%)	N/A
N/A	Painted X Walk1?	No	N/A	Painted X Walk2?	No
	X Walk 1 Direction	To SE		X Walk 2 Direction	To NE
N/A	X Walk 1 Width (in)	N/A	N/A	X Walk 2 Width (in)	N/A
	X Walk 1 Slope (%)	1.5		X Walk 2 Slope (%)	1.3
	X Walk 1 X Slope (%)	1.8		X Walk 2 X Slope (%)	1.0

N/A	Ramp inside XWalk1?	N/A	N/A	Ramp inside XWalk2?	N/A
	Road Slope (%)	1.1	N/A	Clear Space?	N/A
	Road X Slope (%)	2.5	N/A	Clear Space to XWalk (in)	N/A
N/A	Any Obstructions?	N/A	N/A	Storm Grate/Utility Hazard?	N/A
	Obstruction Type			Storm Grate/Utility Type	
		N/A			N/A
			Yes	Surface Condition? (G/P)	Good

**Remove & Replace Curb Ramp With Two New Directional Ramps or Equivalent.**

Total Cost: \$ 3200.00
